R-004B_TIDE

COVE RD
New Bedford

Inspection Status: Remote Inspection
Inspection Level: Level 2

Project: | New Bedford 3D Regulator Inspections
Owner: | New Bedford, MA
Customer: CCDM Smith

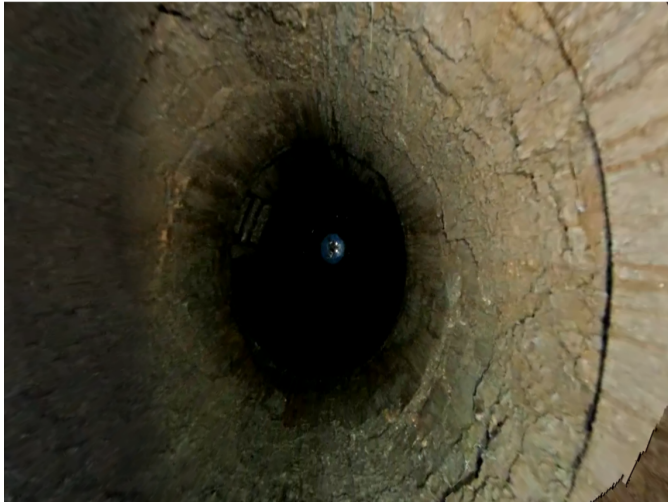
Code: **MGO**
Description: **Miscellaneous General Observation**

Distance: **0ft**
Structural Grade: **0**
O&M Grade: **0**
Clock Start/From:
Clock To:
1st Value:
2nd Value:
Value Percent:
Continuous Index:
Within Eight" of Joint: **False**
Remarks: **Start inspection**

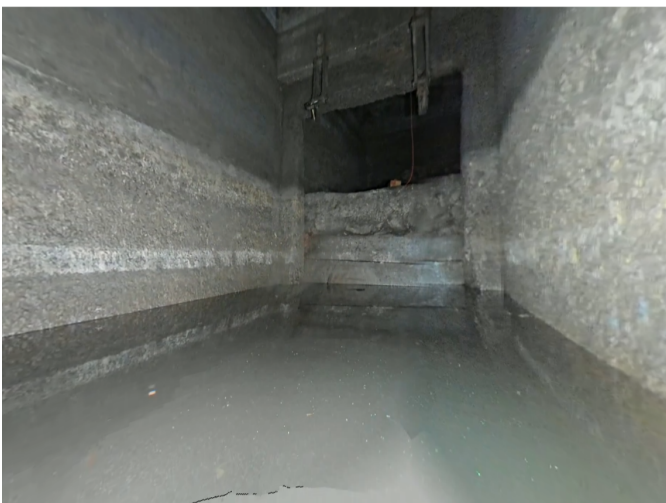
Code: **MGO**
Description: **Miscellaneous General
Observation**

Distance: **8ft**
Structural Grade: **0**
O&M Grade: **0**
Clock Start/From:
Clock To:
1st Value:
2nd Value:
Value Percent:
Continuous Index:
Within Eight" of Joint: **False**
Remarks: **End inspection**
