R-004E

RIVE ST
New Bedford

Inspection Status: Remote Inspection
Inspection Level: Level 2

Project: | New Bedford 3D Regulator Inspections
Owner: New Bedford, MA
Customer: CDM Smith

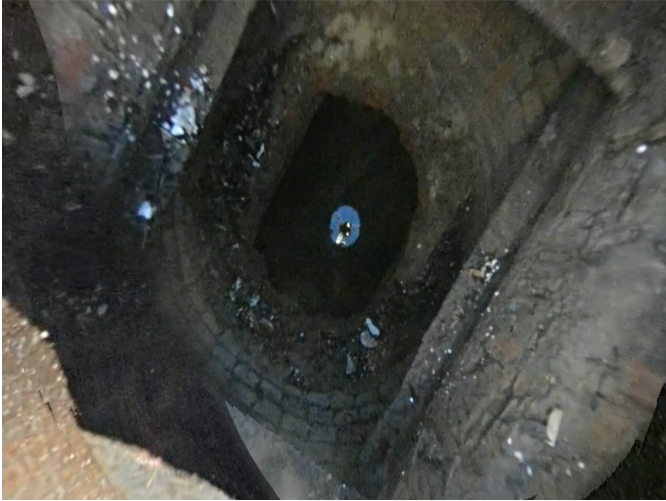
Code: **MGO**
Description: **Miscellaneous General Observation**

Distance: **0ft**
Structural Grade: **0**
O&M Grade: **0**
Clock Start/From:
Clock To:
1st Value:
2nd Value:
Value Percent:
Continuous Index:
Within Eight" of Joint: **False**
Remarks: **Start inspection**

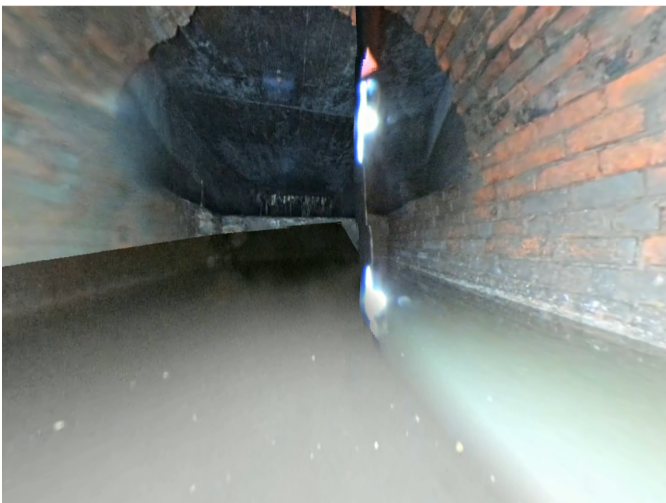
Code: **MGO**
Description: **Miscellaneous General Observation**

Distance: **6ft**
Structural Grade: **0**
O&M Grade: **0**
Clock Start/From:
Clock To:
1st Value:
2nd Value:
Value Percent:
Continuous Index:
Within Eight" of Joint: **False**
Remarks: **End inspection**
