# R-004F

RIVET ST  
New Bedford

**Project:** | New Bedford 3D Regulator Inspections  
**Owner:** New Bedford, MA  
**Customer:** CDM Smith

# Condition Report

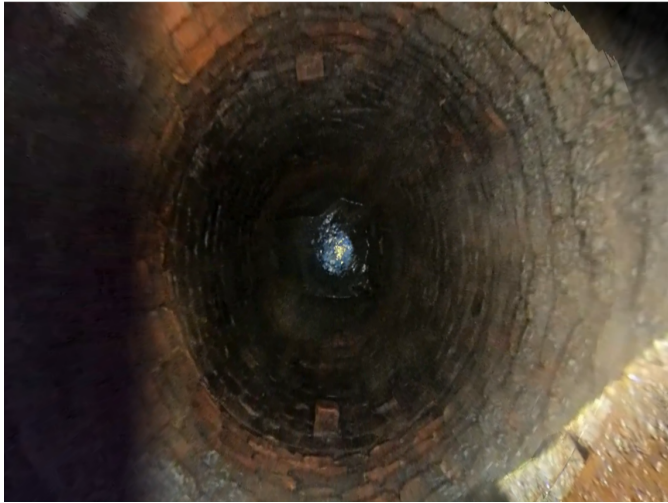
Code: **MGO**  
Description: **Miscellaneous General Observation**

Distance: **0ft**  
Structural Grade: **0**  
O&M Grade: **0**  
Clock Start/From:  
Clock To:  
1st Value:  
2nd Value:  
Value Percent:  
Continuous Index:  
Within Eight" of Joint: **False**  
Remarks: **Start inspection**

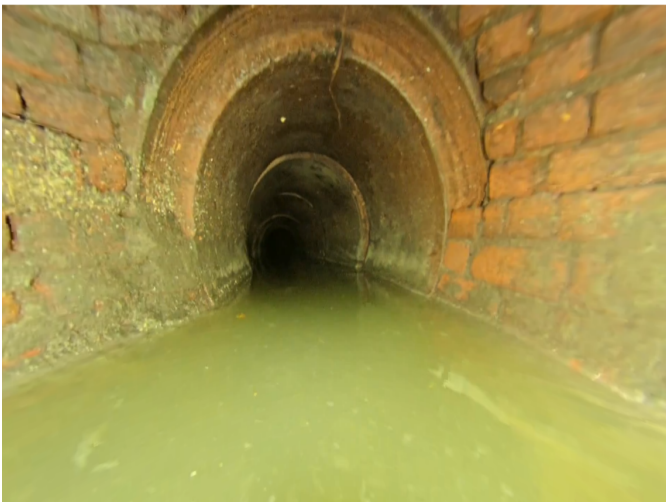
Code: **MGO**  
Description: **Miscellaneous General Observation**

Distance: **7ft**  
Structural Grade: **0**  
O&M Grade: **0**  
Clock Start/From:  
Clock To:  
1st Value:  
2nd Value:  
Value Percent:  
Continuous Index:  
Within Eight" of Joint: **False**  
Remarks: **End inspection**
