R-004H

COVE RD
New Bedford

Inspection Status: Remote Inspection
Inspection Level: Level 2

Project: | New Bedford 3D Regulator Inspections
Owner: New Bedford, MA
Customer: CDM Smith

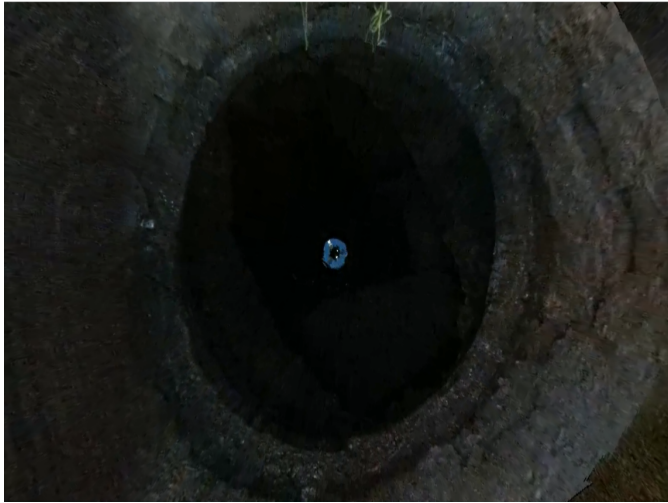
Code: **MGO**
Description: **Miscellaneous General Observation**

Distance: **0ft**
Structural Grade: **0**
O&M Grade: **0**
Clock Start/From:
Clock To:
1st Value:
2nd Value:
Value Percent:
Continuous Index:
Within Eight" of Joint: **False**
Remarks: **Start inspection**

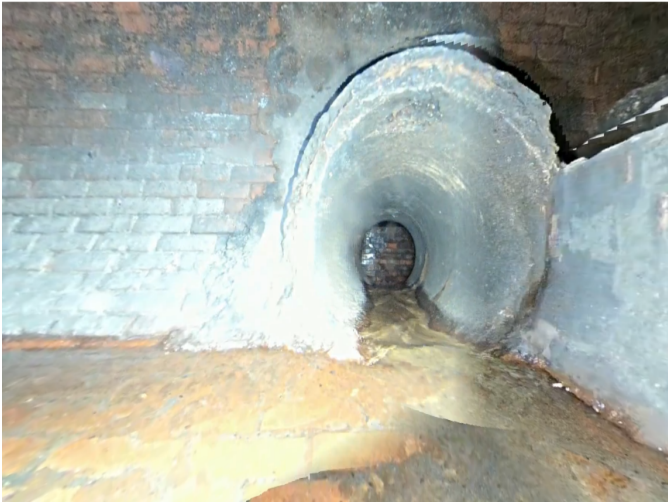
Code: **MGO**
Description: **Miscellaneous General Observation**

Distance: **8ft**
Structural Grade: **0**
O&M Grade: **0**
Clock Start/From:
Clock To:
1st Value:
2nd Value:
Value Percent:
Continuous Index:
Within Eight" of Joint: **False**
Remarks: **End inspection**
