R-004I

DAVID ST
New Bedford

Inspection Status: Remote Inspection
Inspection Level: Level 2

Project: | New Bedford 3D Regulator Inspections

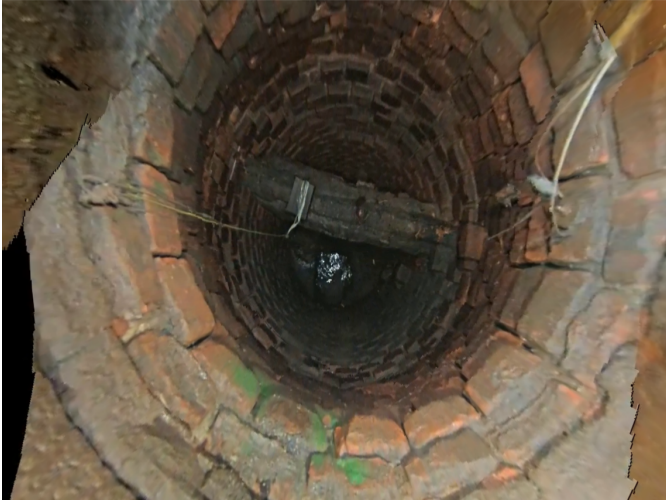
Code: **MGO**
Description: **Miscellaneous General Observation**

Distance: **0ft**
Structural Grade: **0**
O&M Grade: **0**
Clock Start/From:
Clock To:
1st Value:
2nd Value:
Value Percent:
Continuous Index:
Within Eight" of Joint: **False**
Remarks: **Start inspection**

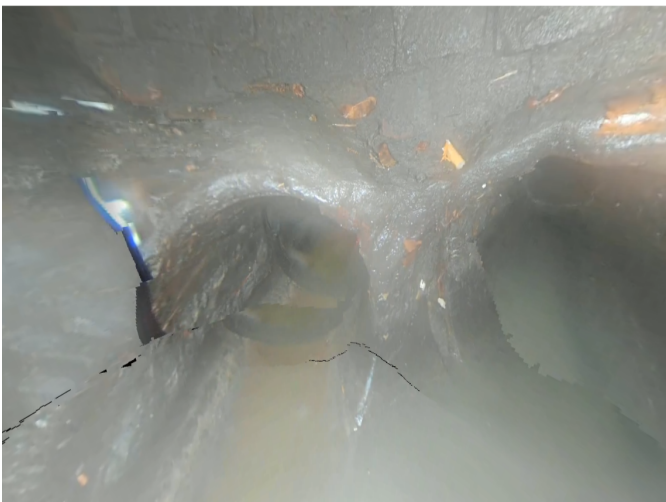
Code: **MGO**
Description: **Miscellaneous General Observation**

Distance: **7ft**
Structural Grade: **0**
O&M Grade: **0**
Clock Start/From:
Clock To:
1st Value:
2nd Value:
Value Percent:
Continuous Index:
Within Eight" of Joint: **False**
Remarks: **End inspection**
