# R-006B

OAKLAWN ST  
New Bedford

Inspection Status: Remote Inspection  
Inspection Level: Level 2

**Project:** | New Bedford 3D Regulator Inspections

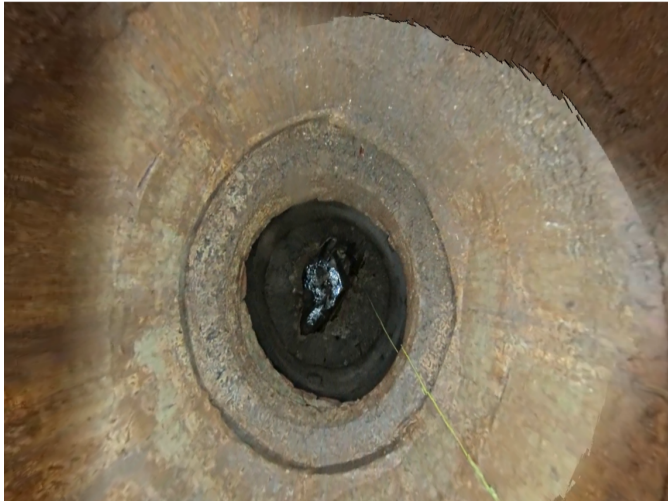
Code: **MGO**  
Description: **Miscellaneous General Observation**

Distance: **0ft**  
Structural Grade: **0**  
O&M Grade: **0**  
Clock Start/From:  
Clock To:  
1st Value:  
2nd Value:  
Value Percent:  
Continuous Index:  
Within Eight" of Joint: **False**  
Remarks: **Start inspection**

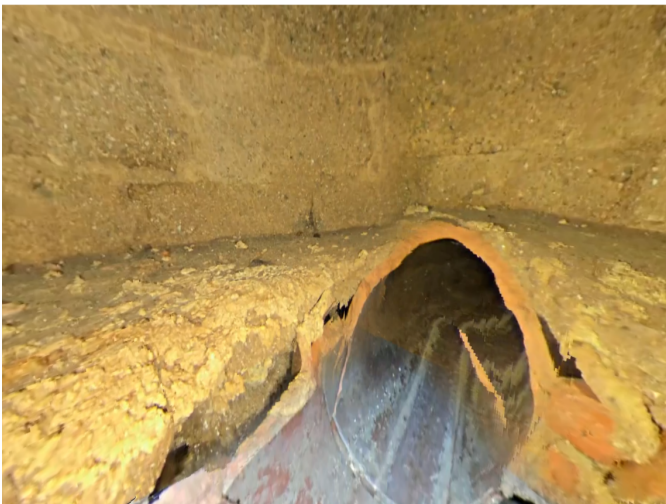
Code: **MGO**  
Description: **Miscellaneous General  
Observation**

Distance: **7ft**  
Structural Grade: **0**  
O&M Grade: **0**  
Clock Start/From:  
Clock To:  
1st Value:  
2nd Value:  
Value Percent:  
Continuous Index:  
Within Eight" of Joint: **False**  
Remarks: **End inspection**
