R-006D

LUCAS ST
New Bedford

Inspection Status: Remote Inspection
Inspection Level: Level 2

Project: | New Bedford 3D Regulator Inspections

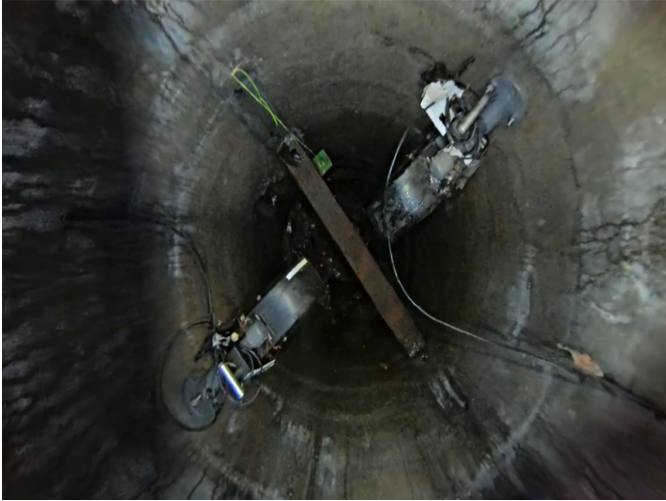
Code: **MGO**
Description: **Miscellaneous General Observation**

Distance: **0ft**
Structural Grade: **0**
O&M Grade: **0**
Clock Start/From:
Clock To:
1st Value:
2nd Value:
Value Percent:
Continuous Index:
Within Eight" of Joint: **False**
Remarks: **Start inspection**

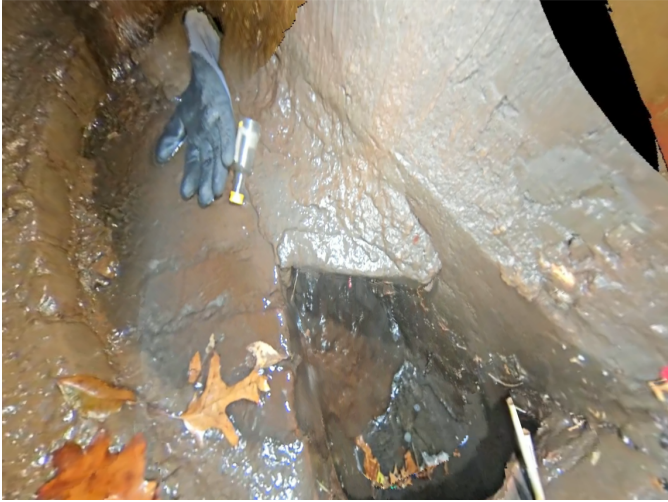
Code: **MGO**
Description: **Miscellaneous General Observation**

Distance: **5ft**
Structural Grade: **0**
O&M Grade: **0**
Clock Start/From:
Clock To:
1st Value:
2nd Value:
Value Percent:
Continuous Index:
Within Eight" of Joint: **False**
Remarks: **End inspection**
