# R-008A

CALUMET ST  
New Bedford

**Project:** | New Bedford 3D Regulator Inspections

# Condition Report

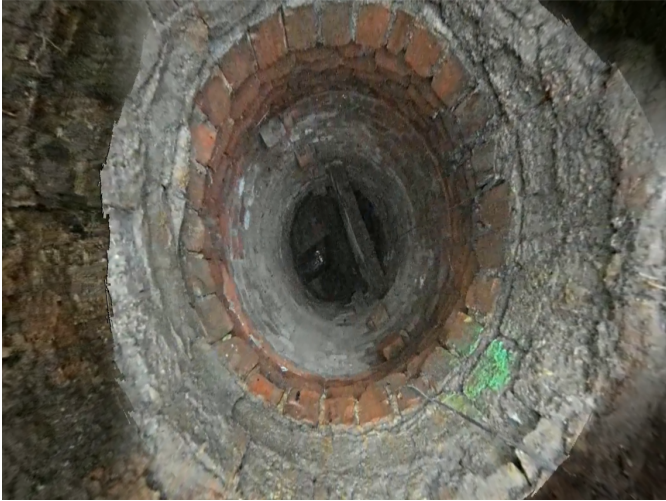
Code: **MGO**  
Description: **Miscellaneous General Observation**

Distance: **0ft**  
Structural Grade: **0**  
O&M Grade: **0**  
Clock Start/From:  
Clock To:  
1st Value:  
2nd Value:  
Value Percent:  
Continuous Index:  
Within Eight" of Joint: **False**  
Remarks: **Start inspection**

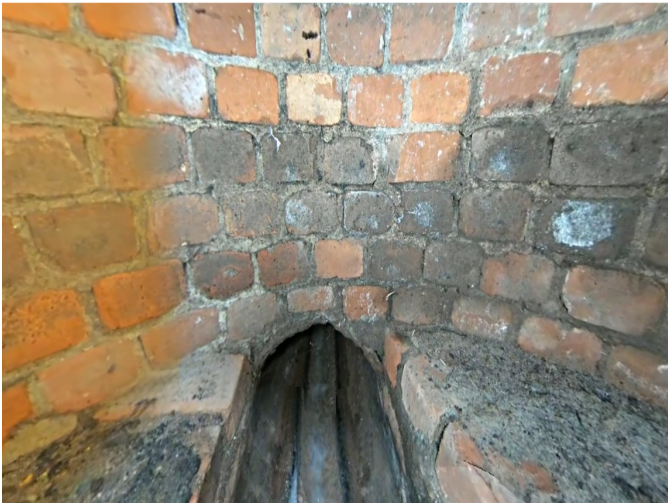
Code: **MGO**  
Description: **Miscellaneous General Observation**

Distance: **7ft**  
Structural Grade: **0**  
O&M Grade: **0**  
Clock Start/From:  
Clock To:  
1st Value:  
2nd Value:  
Value Percent:  
Continuous Index:  
Within Eight" of Joint: **False**  
Remarks: **End inspection**
