R-009A

AQUIDNECK ST
New Bedford

Inspection Status: Remote Inspection
Inspection Level: Level 2

Project: | New Bedford 3D Regulator Inspections

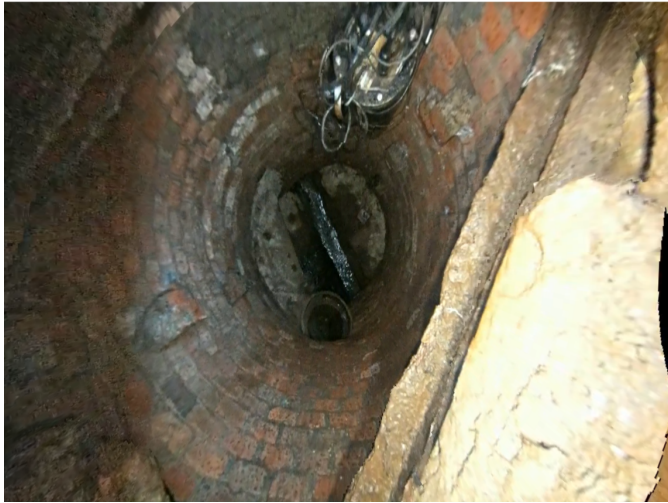
Code: **MGO**
Description: **Miscellaneous General Observation**

Distance: **0ft**
Structural Grade: **0**
O&M Grade: **0**
Clock Start/From:
Clock To:
1st Value:
2nd Value:
Value Percent:
Continuous Index:
Within Eight" of Joint: **False**
Remarks: **Start inspection**

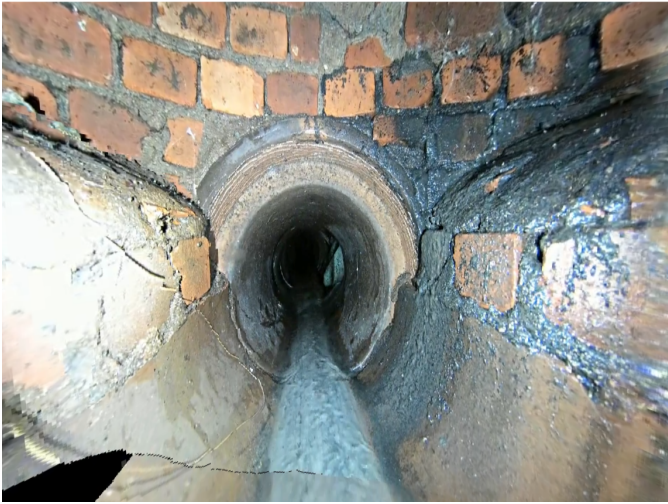
Code: **MGO**
Description: **Miscellaneous General Observation**

Distance: **7ft**
Structural Grade: **0**
O&M Grade: **0**
Clock Start/From:
Clock To:
1st Value:
2nd Value:
Value Percent:
Continuous Index:
Within Eight" of Joint: **False**
Remarks: **End inspection**
