R-010A

BELLEVUE ST
New Bedford

Inspection Status: Remote Inspection
Inspection Level: Level 2

Project: | New Bedford 3D Regulator Inspections

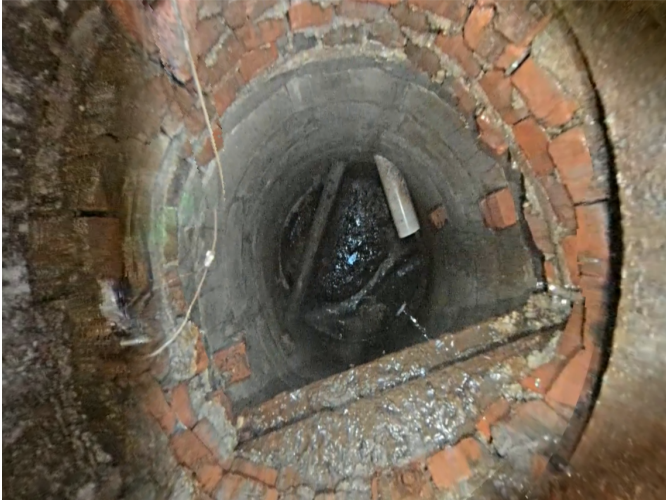
Code: **MGO**
Description: **Miscellaneous General Observation**

Distance: **0ft**
Structural Grade: **0**
O&M Grade: **0**
Clock Start/From:
Clock To:
1st Value:
2nd Value:
Value Percent:
Continuous Index:
Within Eight" of Joint: **False**
Remarks: **Start inspection**

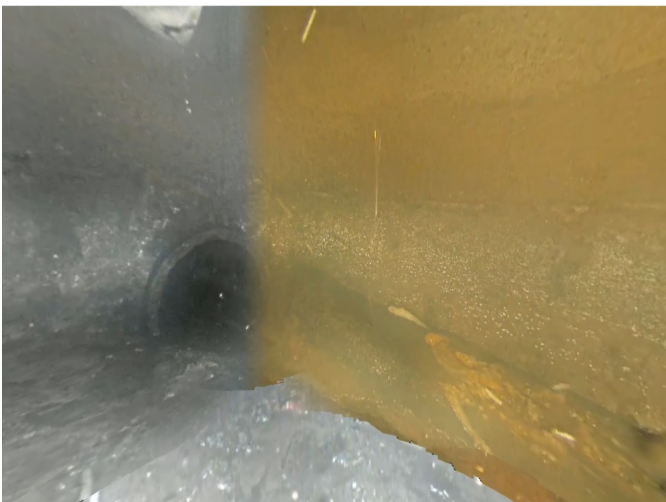
Code: **MGO**
Description: **Miscellaneous General Observation**

Distance: **6ft**
Structural Grade: **0**
O&M Grade: **0**
Clock Start/From:
Clock To:
1st Value:
2nd Value:
Value Percent:
Continuous Index:
Within Eight" of Joint: **False**
Remarks: **End inspection**
