R-012A

RICKETSON ST
New Bedford

Inspection Status: Remote Inspection
Inspection Level: Level 2

Project: | New Bedford 3D Regulator Inspections

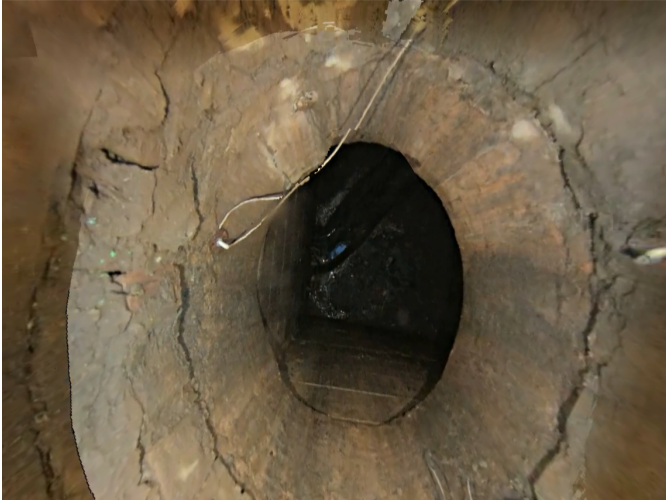
Code: **MGO**
Description: **Miscellaneous General Observation**

Distance: **0ft**
Structural Grade: **0**
O&M Grade: **0**
Clock Start/From:
Clock To:
1st Value:
2nd Value:
Value Percent:
Continuous Index:
Within Eight" of Joint: **False**
Remarks: **Start inspection**

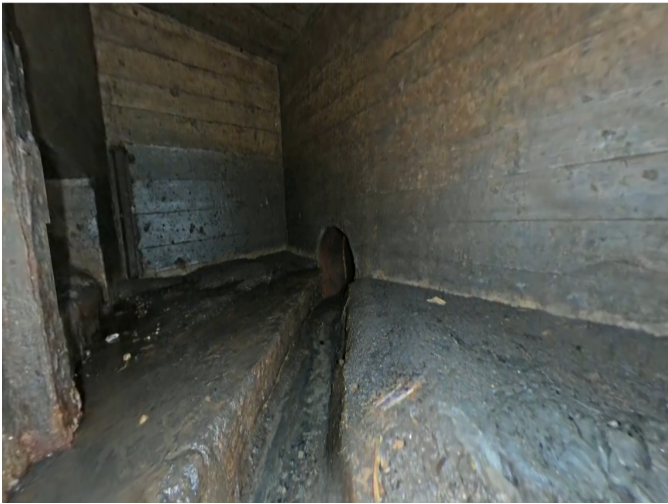
Code: **MGO**
Description: **Miscellaneous General Observation**

Distance: **5ft**
Structural Grade: **0**
O&M Grade: **0**
Clock Start/From:
Clock To:
1st Value:
2nd Value:
Value Percent:
Continuous Index:
Within Eight" of Joint: **False**
Remarks: **End inspection**
