# R-013A

AQUIDNECK ST  
New Bedford

Inspection Status: Remote Inspection  
Inspection Level: Level 2

**Project:** | New Bedford 3D Regulator Inspections

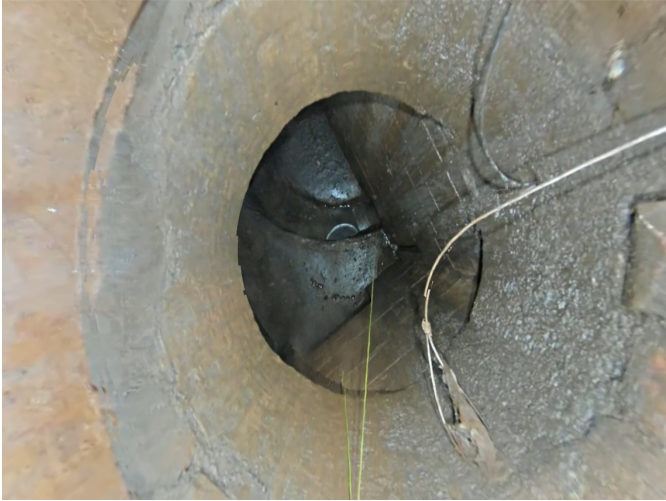
Code: **MGO**  
Description: **Miscellaneous General Observation**

Distance: **0ft**  
Structural Grade: **0**  
O&M Grade: **0**  
Clock Start/From:  
Clock To:  
1st Value:  
2nd Value:  
Value Percent:  
Continuous Index:  
Within Eight" of Joint: **False**  
Remarks: **Start inspection**

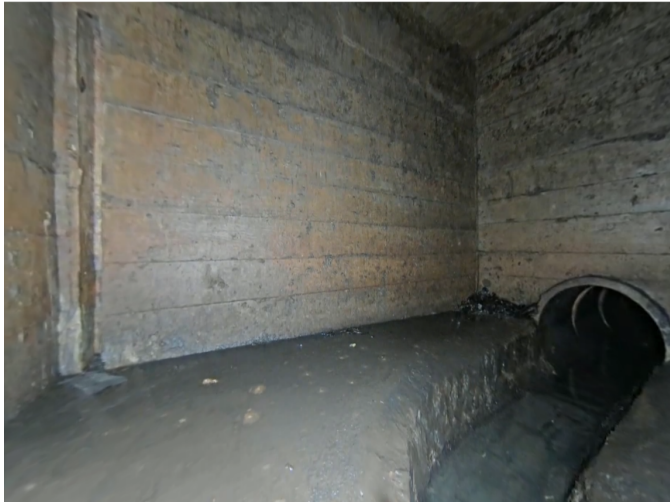
Code: **MGO**  
Description: **Miscellaneous General Observation**

Distance: **5ft**  
Structural Grade: **0**  
O&M Grade: **0**  
Clock Start/From:  
Clock To:  
1st Value:  
2nd Value:  
Value Percent:  
Continuous Index:  
Within Eight" of Joint: **False**  
Remarks: **End inspection**
