R-016A

FREDERICK ST
New Bedford

Inspection Status: Remote Inspection
Inspection Level: Level 2

Project: | New Bedford 3D Regulator Inspections

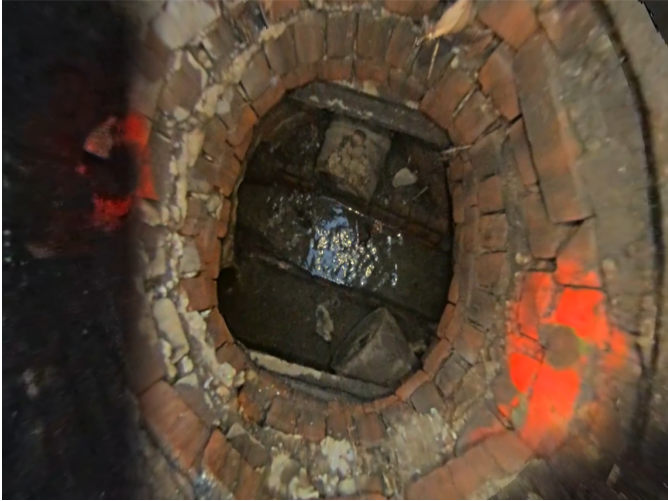
Code: **MGO**
Description: **Miscellaneous General Observation**

Distance: **0ft**
Structural Grade: **0**
O&M Grade: **0**
Clock Start/From:
Clock To:
1st Value:
2nd Value:
Value Percent:
Continuous Index:
Within Eight" of Joint: **False**
Remarks: **Start inspection**

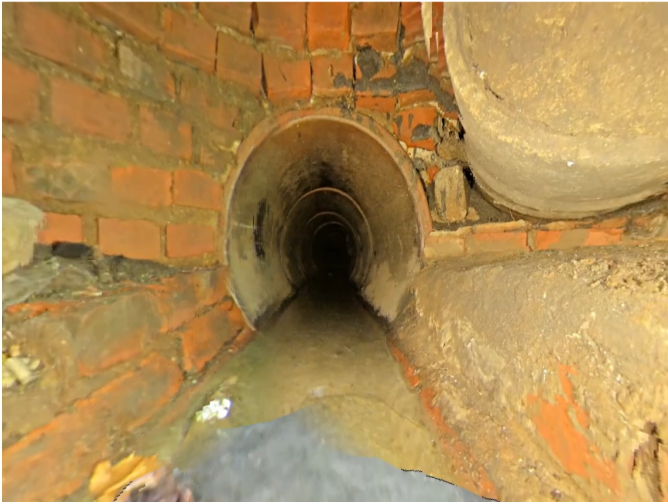
Code: **MGO**
Description: **Miscellaneous General Observation**

Distance: **3ft**
Structural Grade: **0**
O&M Grade: **0**
Clock Start/From:
Clock To:
1st Value:
2nd Value:
Value Percent:
Continuous Index:
Within Eight" of Joint: **False**
Remarks: **End inspection**
