R-017A

RODNEY ST
New Bedford

Project: | New Bedford 3D Regulator Inspections

Condition Report

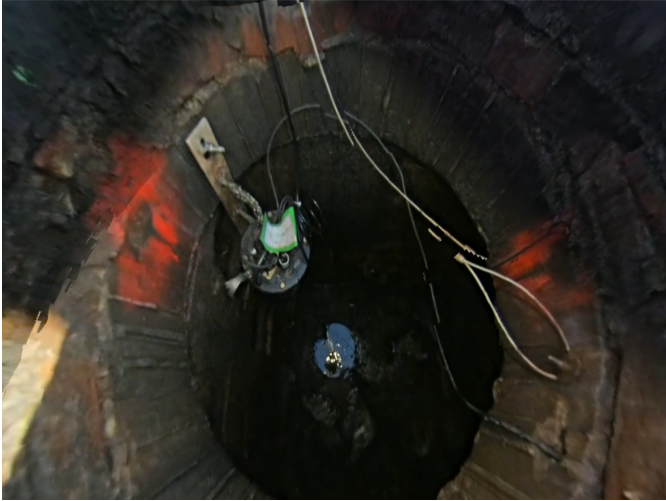
Code: **MGO**
Description: **Miscellaneous General Observation**

Distance: **0ft**
Structural Grade: **0**
O&M Grade: **0**
Clock Start/From:
Clock To:
1st Value:
2nd Value:
Value Percent:
Continuous Index:
Within Eight" of Joint: **False**
Remarks: **Start inspection**

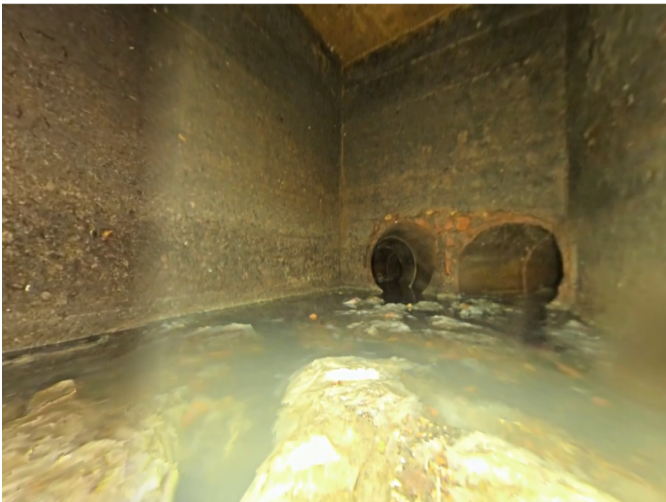
Code: **MGO**
Description: **Miscellaneous General
Observation**

Distance: **5ft**
Structural Grade: **0**
O&M Grade: **0**
Clock Start/From:
Clock To:
1st Value:
2nd Value:
Value Percent:
Continuous Index:
Within Eight" of Joint: **False**
Remarks: **End inspection**
