# R-017D

RUTH ST  
New Bedford

**Project:** | New Bedford 3D Regulator Inspections

# Condition Report

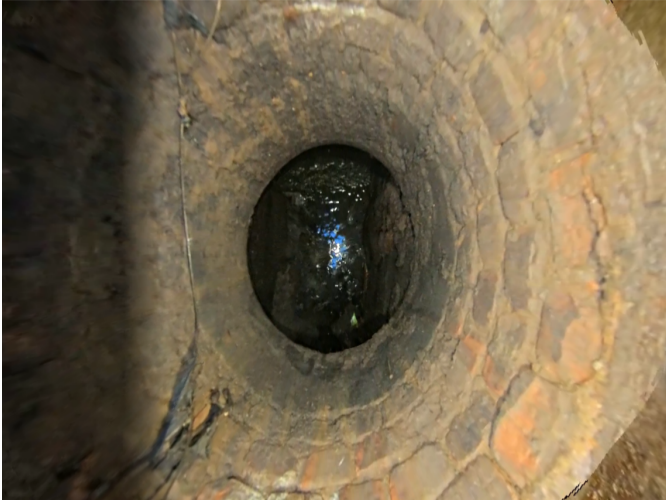
Code: **MGO**  
Description: **Miscellaneous General Observation**

Distance: **0ft**  
Structural Grade: **0**  
O&M Grade: **0**  
Clock Start/From:  
Clock To:  
1st Value:  
2nd Value:  
Value Percent:  
Continuous Index:  
Within Eight" of Joint: **False**  
Remarks: **Start inspection**

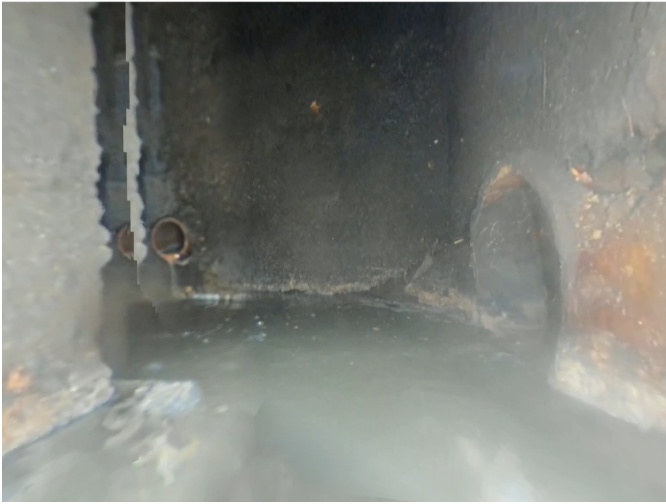
Code: **MGO**  
Description: **Miscellaneous General Observation**

Distance: **7ft**  
Structural Grade: **0**  
O&M Grade: **0**  
Clock Start/From:  
Clock To:  
1st Value:  
2nd Value:  
Value Percent:  
Continuous Index:  
Within Eight" of Joint: **False**  
Remarks: **End inspection**
