R-018A

CUYE ST
New Bedford

Project: | New Bedford 3D Regulator Inspections

Owner: New Bedford, MA

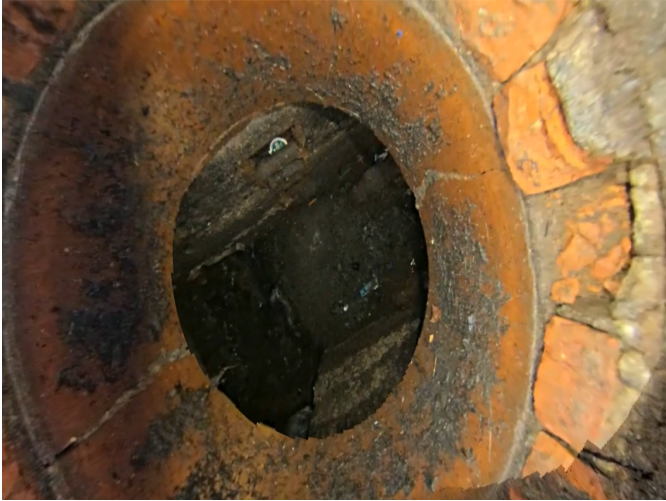
Code: **MGO**
Description: **Miscellaneous General Observation**

Distance: **0ft**
Structural Grade: **0**
O&M Grade: **0**
Clock Start/From:
Clock To:
1st Value:
2nd Value:
Value Percent:
Continuous Index:
Within Eight" of Joint: **False**
Remarks: **Start inspection**
