R-020A

WAMSUTTA ST
New Bedford

Inspection Status: Remote Inspection
Inspection Level: Level 2

Project: | New Bedford 3D Regulator Inspections

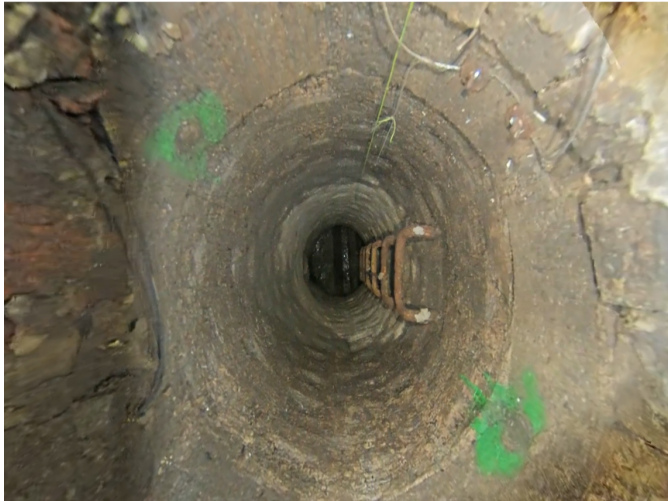
Code: **MGO**
Description: **Miscellaneous General Observation**

Distance: **0ft**
Structural Grade: **0**
O&M Grade: **0**
Clock Start/From:
Clock To:
1st Value:
2nd Value:
Value Percent:
Continuous Index:
Within Eight" of Joint: **False**
Remarks: **Start inspection**

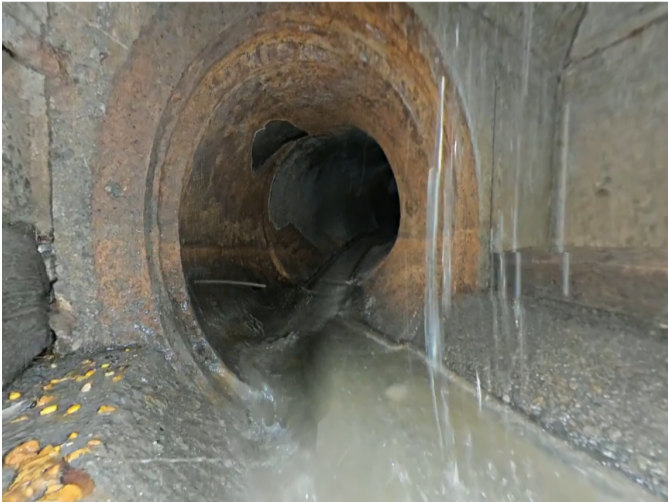
Code: **MGO**
Description: **Miscellaneous General Observation**

Distance: **11ft**
Structural Grade: **0**
O&M Grade: **0**
Clock Start/From:
Clock To:
1st Value:
2nd Value:
Value Percent:
Continuous Index:
Within Eight" of Joint: **False**
Remarks: **End inspection**
