R-020B

ACUSHNET ST
New Bedford

Inspection Status: Remote Inspection
Inspection Level: Level 2

Project: | New Bedford 3D Regulator Inspections

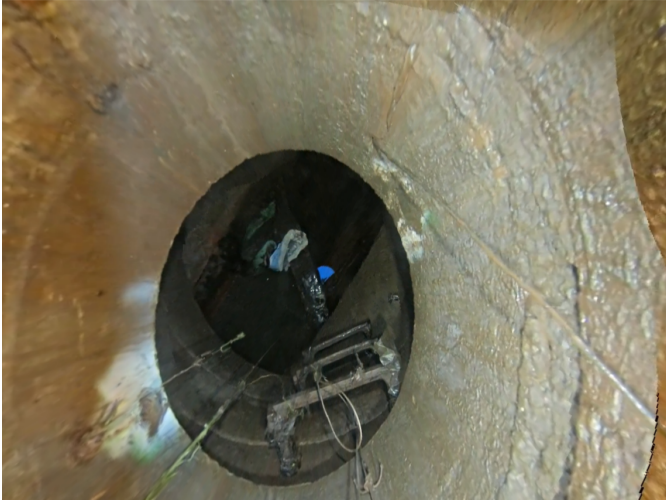
Code: **MGO**
Description: **Miscellaneous General Observation**

Distance: **0ft**
Structural Grade: **0**
O&M Grade: **0**
Clock Start/From:
Clock To:
1st Value:
2nd Value:
Value Percent:
Continuous Index:
Within Eight" of Joint: **False**
Remarks: **Start inspection**

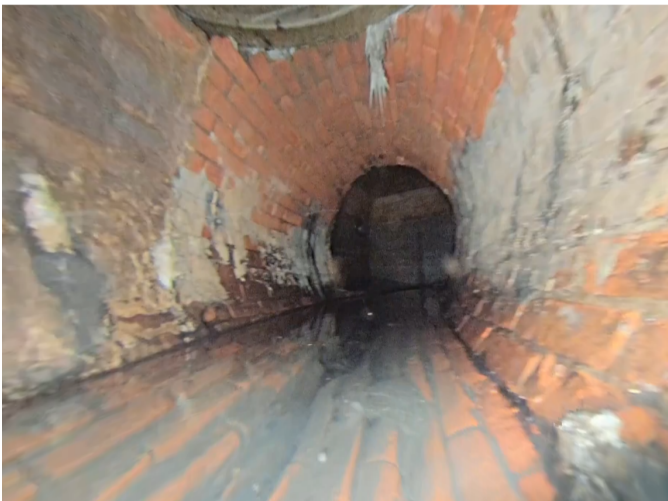
Code: **MGO**
Description: **Miscellaneous General Observation**

Distance: **7ft**
Structural Grade: **0**
O&M Grade: **0**
Clock Start/From:
Clock To:
1st Value:
2nd Value:
Value Percent:
Continuous Index:
Within Eight" of Joint: **False**
Remarks: **End inspection**
