# R-021A

WASHBURN ST  
New Bedford

**Project:** | New Bedford 3D Regulator Inspections

# Condition Report

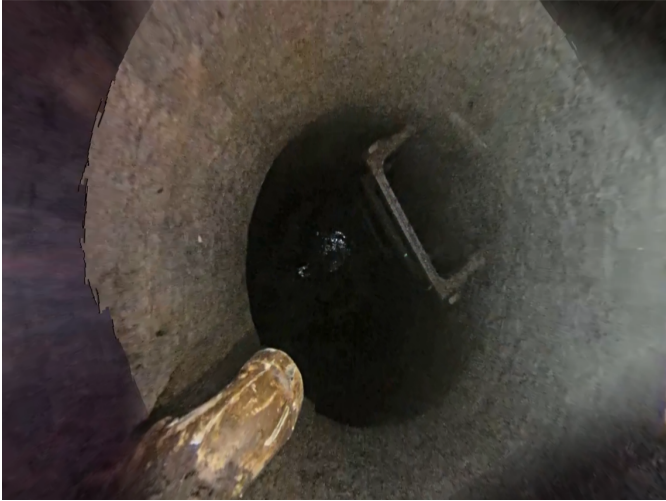
Code: **MGO**  
Description: **Miscellaneous General Observation**

Distance: **0ft**  
Structural Grade: **0**  
O&M Grade: **0**  
Clock Start/From:  
Clock To:  
1st Value:  
2nd Value:  
Value Percent:  
Continuous Index:  
Within Eight" of Joint: **False**  
Remarks: **Start inspection**

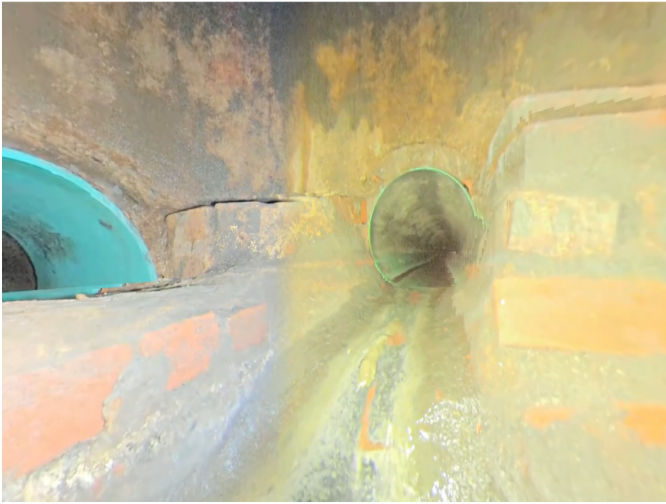
Code: **MGO**  
Description: **Miscellaneous General Observation**

Distance: **9ft**  
Structural Grade: **0**  
O&M Grade: **0**  
Clock Start/From:  
Clock To:  
1st Value:  
2nd Value:  
Value Percent:  
Continuous Index:  
Within Eight" of Joint: **False**  
Remarks: **End inspection**
