R-022C

BELLEVILLE AVE
New Bedford

Inspection Status: Remote Inspection
Inspection Level: Level 2

Project: | New Bedford 3D Regulator Inspections

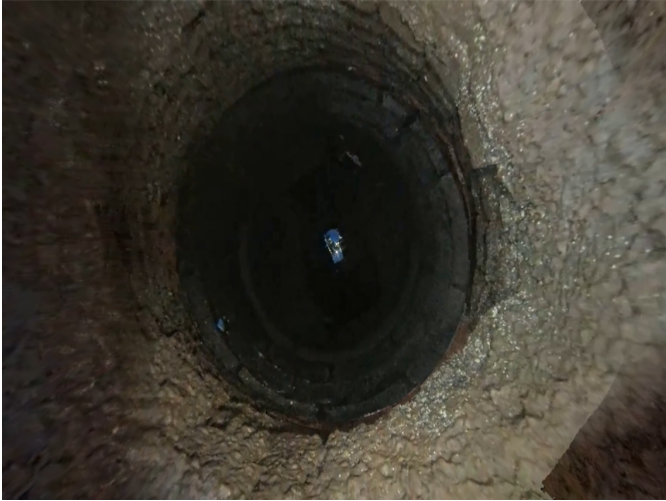
Code: **MGO**
Description: **Miscellaneous General Observation**

Distance: **0ft**
Structural Grade: **0**
O&M Grade: **0**
Clock Start/From:
Clock To:
1st Value:
2nd Value:
Value Percent:
Continuous Index:
Within Eight" of Joint: **False**
Remarks: **Start inspection**

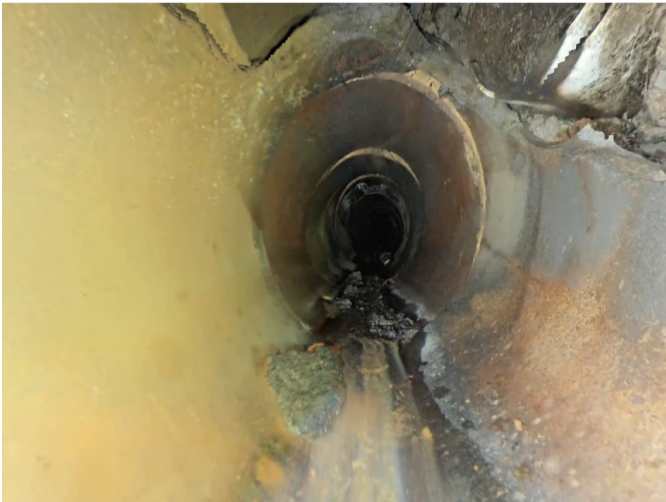
Code: **MGO**
Description: **Miscellaneous General Observation**

Distance: **7ft**
Structural Grade: **0**
O&M Grade: **0**
Clock Start/From:
Clock To:
1st Value:
2nd Value:
Value Percent:
Continuous Index:
Within Eight" of Joint: **False**
Remarks: **End inspection**
