R-022D

PURCHASE ST
New Bedford

Project: | New Bedford 3D Regulator Inspections

Condition Report

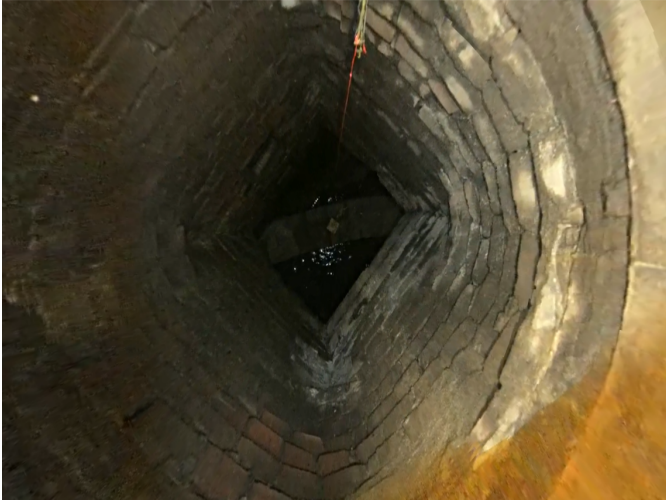
Code: **MGO**
Description: **Miscellaneous General Observation**

Distance: **0ft**
Structural Grade: **0**
O&M Grade: **0**
Clock Start/From:
Clock To:
1st Value:
2nd Value:
Value Percent:
Continuous Index:
Within Eight" of Joint: **False**
Remarks: **Start inspection**

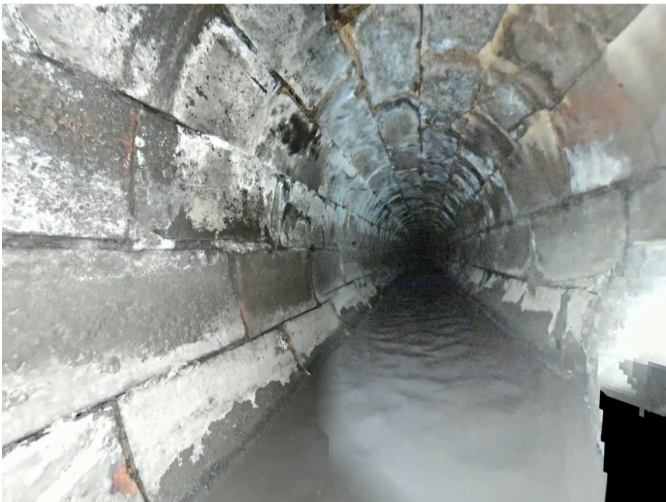
Code: **MGO**
Description: **Miscellaneous General
Observation**

Distance: **7ft**
Structural Grade: **0**
O&M Grade: **0**
Clock Start/From:
Clock To:
1st Value:
2nd Value:
Value Percent:
Continuous Index:
Within Eight" of Joint: **False**
Remarks: **End inspection**
