R-022E

COUNTY ST
New Bedford

Inspection Status: Remote Inspection
Inspection Level: Level 2

Project: | New Bedford 3D Regulator Inspections

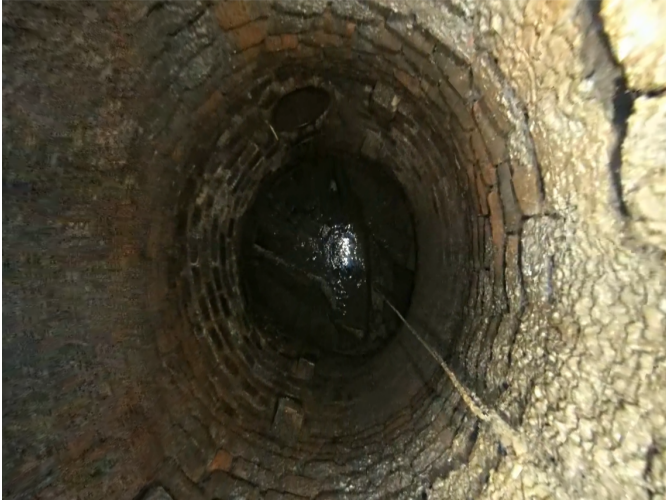
Code: **MGO**
Description: **Miscellaneous General Observation**

Distance: **0ft**
Structural Grade: **0**
O&M Grade: **0**
Clock Start/From:
Clock To:
1st Value:
2nd Value:
Value Percent:
Continuous Index:
Within Eight" of Joint: **False**
Remarks: **Start inspection**

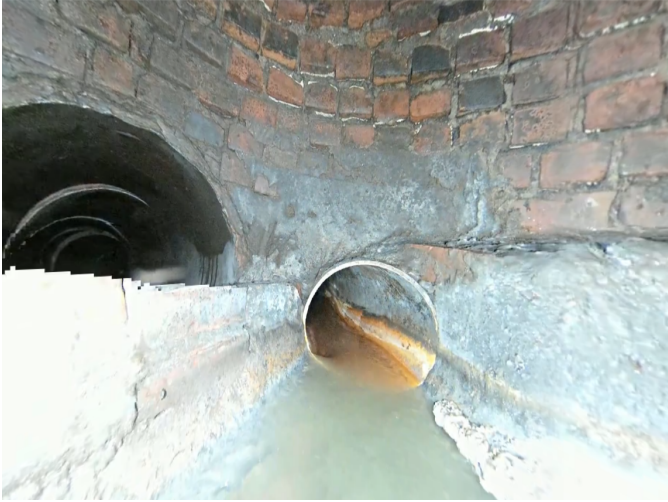
Code: **MGO**
Description: **Miscellaneous General Observation**

Distance: **6ft**
Structural Grade: **0**
O&M Grade: **0**
Clock Start/From:
Clock To:
1st Value:
2nd Value:
Value Percent:
Continuous Index:
Within Eight" of Joint: **False**
Remarks: **End inspection**
