R-022G

HOLLY ST
New Bedford

Inspection Status: Remote Inspection
Inspection Level: Level 2

Project: | New Bedford 3D Regulator Inspections

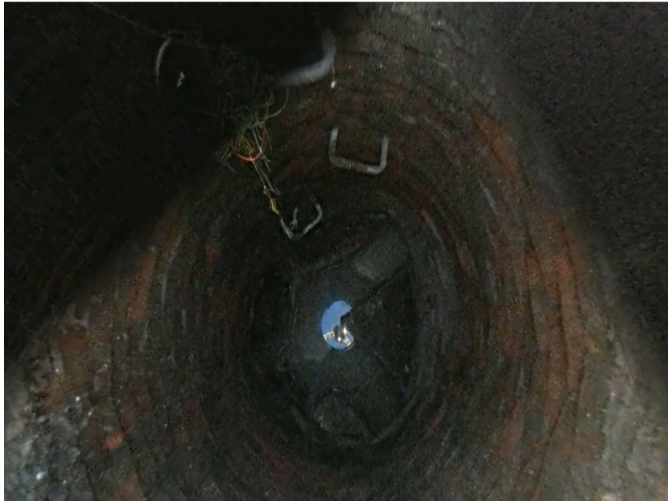
Code: **MGO**
Description: **Miscellaneous General Observation**

Distance: **0ft**
Structural Grade: **0**
O&M Grade: **0**
Clock Start/From:
Clock To:
1st Value:
2nd Value:
Value Percent:
Continuous Index:
Within Eight" of Joint: **False**
Remarks: **Start inspection**

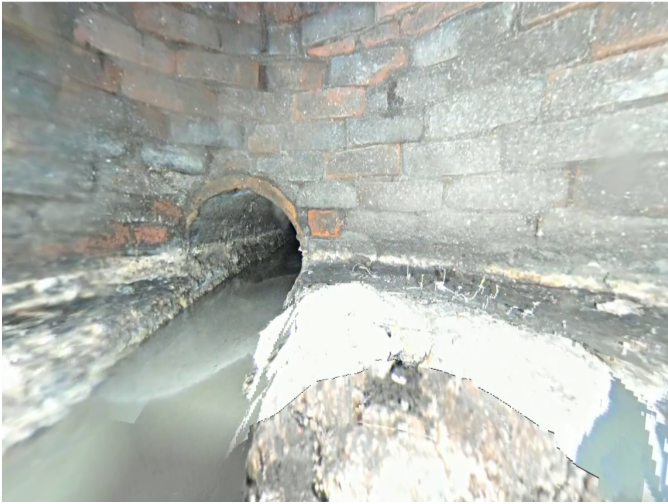
Code: **MGO**
Description: **Miscellaneous General Observation**

Distance: **5ft**
Structural Grade: **0**
O&M Grade: **0**
Clock Start/From:
Clock To:
1st Value:
2nd Value:
Value Percent:
Continuous Index:
Within Eight" of Joint: **False**
Remarks: **End inspection**
