R-024A

BELLEVILLE AVE
New Bedford

Project: | New Bedford 3D Regulator Inspections
Owner: New Bedford, MA
Customer: CDM Smith

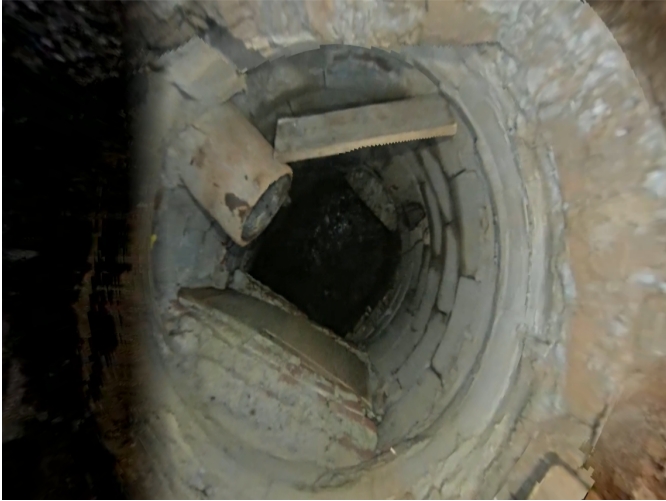
Code: **MGO**
Description: **Miscellaneous General Observation**

Distance: **0ft**
Structural Grade: **0**
O&M Grade: **0**
Clock Start/From:
Clock To:
1st Value:
2nd Value:
Value Percent:
Continuous Index:
Within Eight" of Joint: **False**
Remarks: **Start inspection**

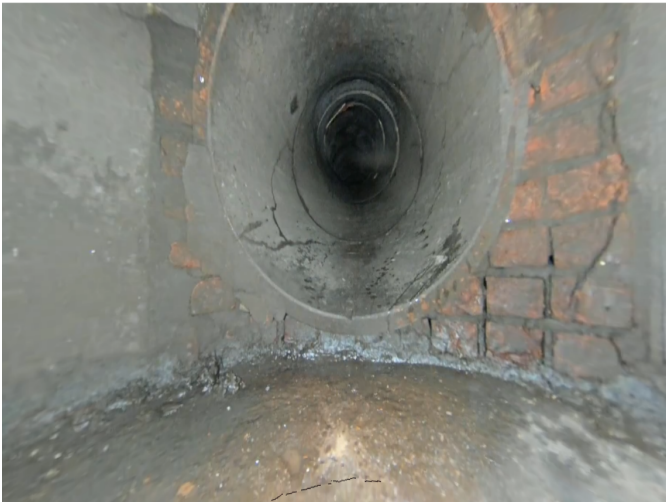
Code: **MGO**
Description: **Miscellaneous General Observation**

Distance: **7ft**
Structural Grade: **0**
O&M Grade: **0**
Clock Start/From:
Clock To:
1st Value:
2nd Value:
Value Percent:
Continuous Index:
Within Eight" of Joint: **False**
Remarks: **End inspection**
