R-026A

RIVER RD
New Bedford

Inspection Status: Remote Inspection
Inspection Level: Level 2

Project: | New Bedford 3D Regulator Inspections

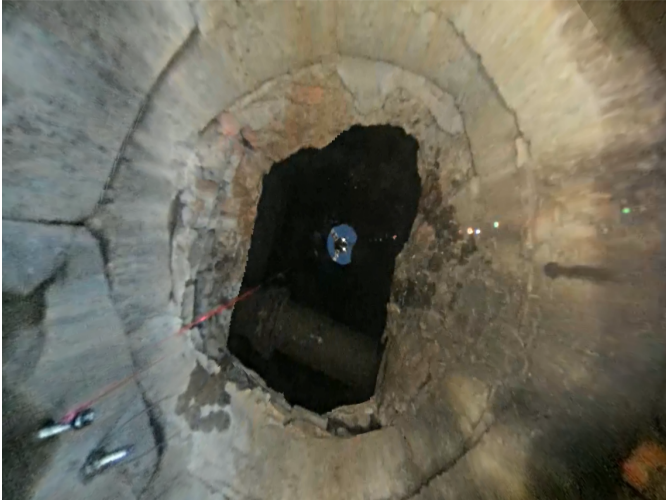
Code: **MGO**
Description: **Miscellaneous General Observation**

Distance: **0ft**
Structural Grade: **0**
O&M Grade: **0**
Clock Start/From:
Clock To:
1st Value:
2nd Value:
Value Percent:
Continuous Index:
Within Eight" of Joint: **False**
Remarks: **Start inspection**

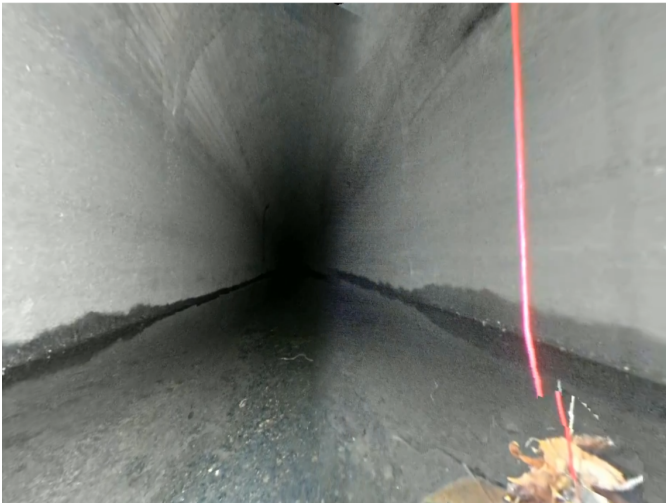
Code: **MGO**
Description: **Miscellaneous General Observation**

Distance: **7ft**
Structural Grade: **0**
O&M Grade: **0**
Clock Start/From:
Clock To:
1st Value:
2nd Value:
Value Percent:
Continuous Index:
Within Eight" of Joint: **False**
Remarks: **End inspection**
