R-027A

RIVER RD
New Bedford

Inspection Status: Remote Inspection
Inspection Level: Level 2

Project: | New Bedford 3D Regulator Inspections

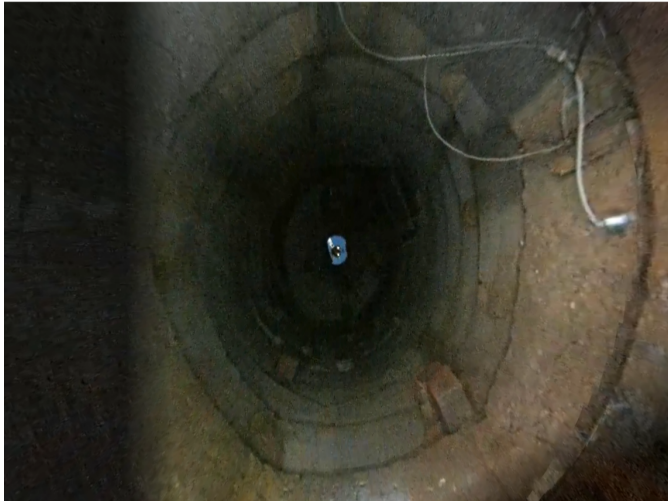
Code: **MGO**
Description: **Miscellaneous General Observation**

Distance: **0ft**
Structural Grade: **0**
O&M Grade: **0**
Clock Start/From:
Clock To:
1st Value:
2nd Value:
Value Percent:
Continuous Index:
Within Eight" of Joint: **False**
Remarks: **Start inspection**

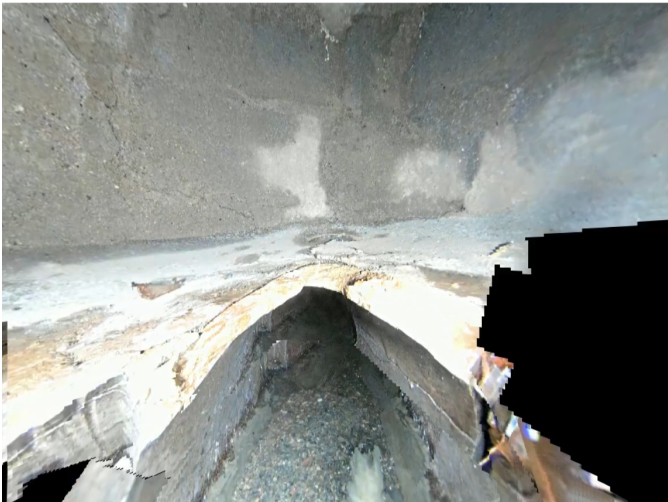
Code: **MGO**
Description: **Miscellaneous General Observation**

Distance: **8ft**
Structural Grade: **0**
O&M Grade: **0**
Clock Start/From:
Clock To:
1st Value:
2nd Value:
Value Percent:
Continuous Index:
Within Eight" of Joint: **False**
Remarks: **End inspection**
