R-027B

OHIO ST
New Bedford

Inspection Status: Remote Inspection
Inspection Level: Level 2

Project: | New Bedford 3D Regulator Inspections

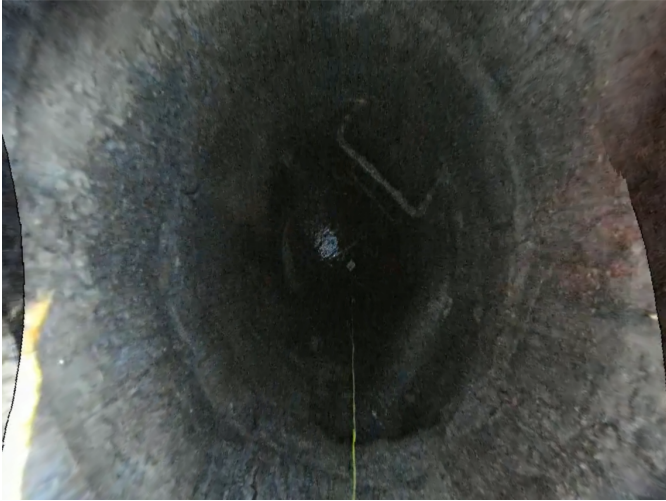
Code: **MGO**
Description: **Miscellaneous General Observation**

Distance: **0ft**
Structural Grade: **0**
O&M Grade: **0**
Clock Start/From:
Clock To:
1st Value:
2nd Value:
Value Percent:
Continuous Index:
Within Eight" of Joint: **False**
Remarks: **Start inspection**

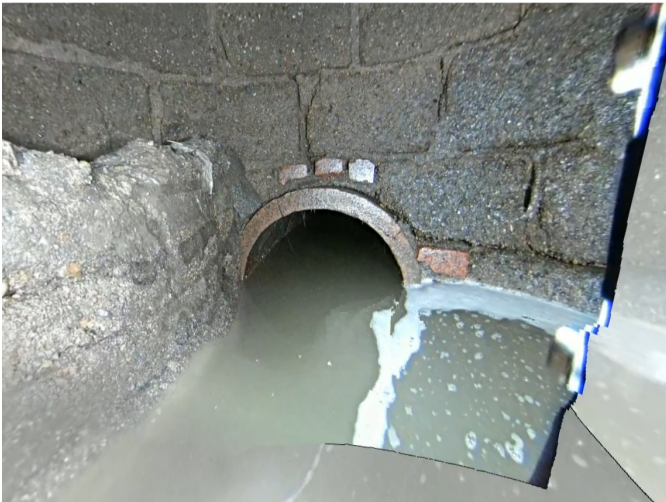
Code: **MGO**
Description: **Miscellaneous General Observation**

Distance: **10ft**
Structural Grade: **0**
O&M Grade: **0**
Clock Start/From:
Clock To:
1st Value:
2nd Value:
Value Percent:
Continuous Index:
Within Eight" of Joint: **False**
Remarks: **End inspection**
