# R-027D

MAZZEPA ST  
New Bedford

Inspection Status: Remote Inspection  
Inspection Level: Level 2

**Project:** | New Bedford 3D Regulator Inspections

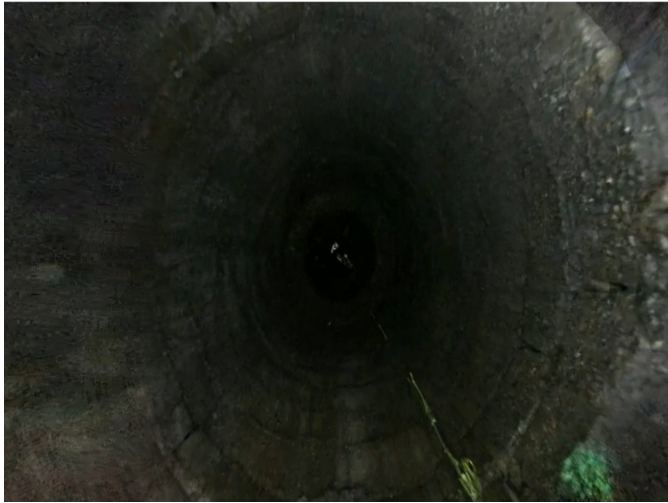
Code: **MGO**  
Description: **Miscellaneous General Observation**

Distance: **0ft**  
Structural Grade: **0**  
O&M Grade: **0**  
Clock Start/From:  
Clock To:  
1st Value:  
2nd Value:  
Value Percent:  
Continuous Index:  
Within Eight" of Joint: **False**  
Remarks: **Start inspection**

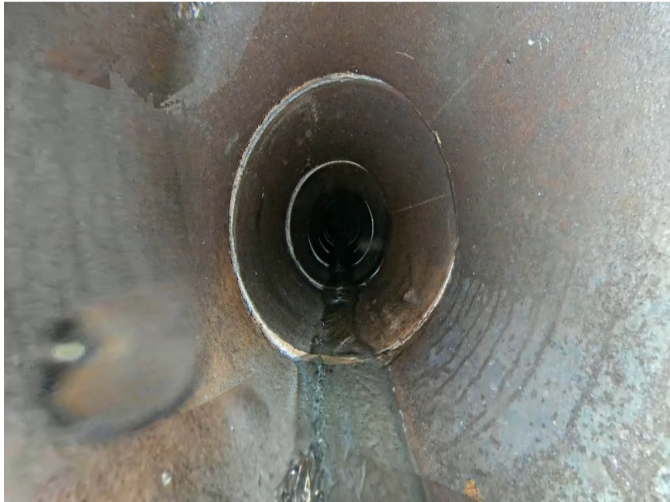
Code: **MGO**  
Description: **Miscellaneous General Observation**

Distance: **12ft**  
Structural Grade: **0**  
O&M Grade: **0**  
Clock Start/From:  
Clock To:  
1st Value:  
2nd Value:  
Value Percent:  
Continuous Index:  
Within Eight" of Joint: **False**  
Remarks: **End inspection**
