R-027E

BELLEVILLE AVE
New Bedford

Inspection Status: Remote Inspection
Inspection Level: Level 2

Project: | New Bedford 3D Regulator Inspections

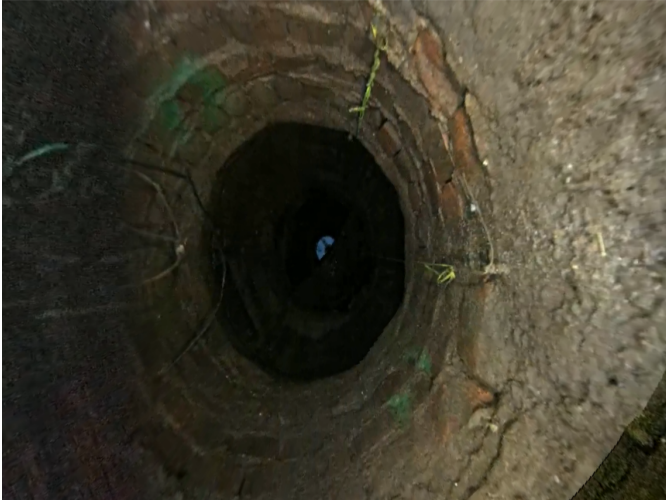
Code: **MGO**
Description: **Miscellaneous General Observation**

Distance: **0ft**
Structural Grade: **0**
O&M Grade: **0**
Clock Start/From:
Clock To:
1st Value:
2nd Value:
Value Percent:
Continuous Index:
Within Eight" of Joint: **False**
Remarks: **Start inspection**

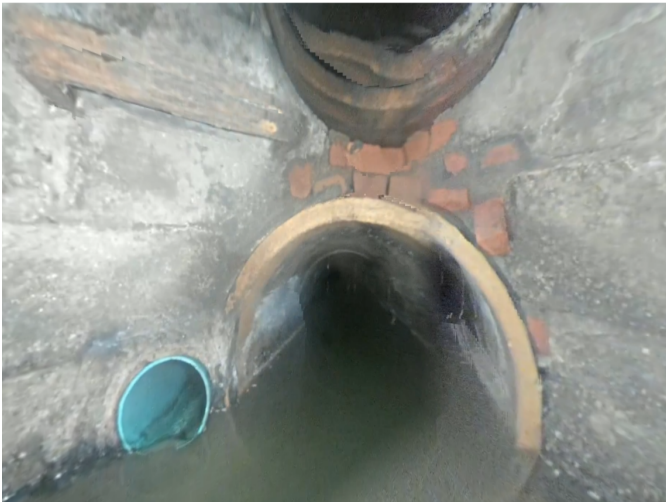
Code: **MGO**
Description: **Miscellaneous General Observation**

Distance: **8ft**
Structural Grade: **0**
O&M Grade: **0**
Clock Start/From:
Clock To:
1st Value:
2nd Value:
Value Percent:
Continuous Index:
Within Eight" of Joint: **False**
Remarks: **End inspection**
