R-027F

BELLEVILLE AVE
New Bedford

Inspection Status: Remote Inspection
Inspection Level: Level 2

Project: | New Bedford 3D Regulator Inspections

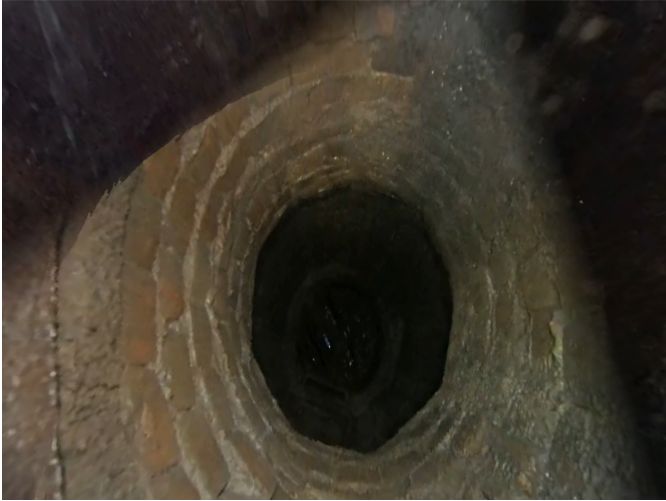
Code: **MGO**
Description: **Miscellaneous General Observation**

Distance: **0ft**
Structural Grade: **0**
O&M Grade: **0**
Clock Start/From:
Clock To:
1st Value:
2nd Value:
Value Percent:
Continuous Index:
Within Eight" of Joint: **False**
Remarks: **Start inspection**

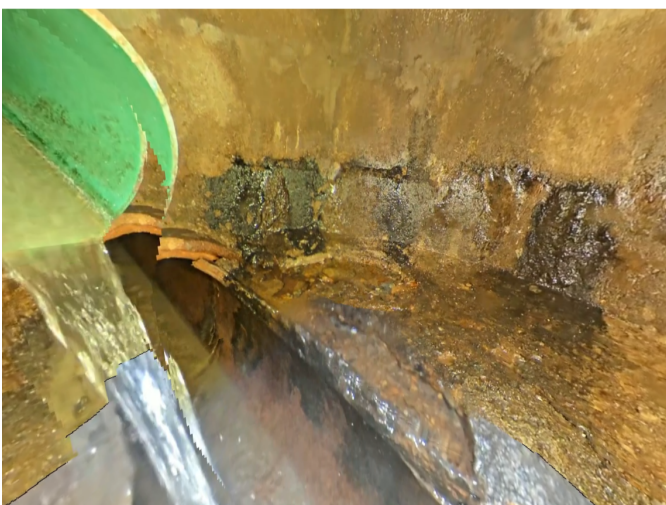
Code: **MGO**
Description: **Miscellaneous General
Observation**

Distance: **10ft**
Structural Grade: **0**
O&M Grade: **0**
Clock Start/From:
Clock To:
1st Value:
2nd Value:
Value Percent:
Continuous Index:
Within Eight" of Joint: **False**
Remarks: **End inspection**
