R-027G

BELLEVILLE AVE
New Bedford

Inspection Status: Remote Inspection
Inspection Level: Level 2

Project: | New Bedford 3D Regulator Inspections

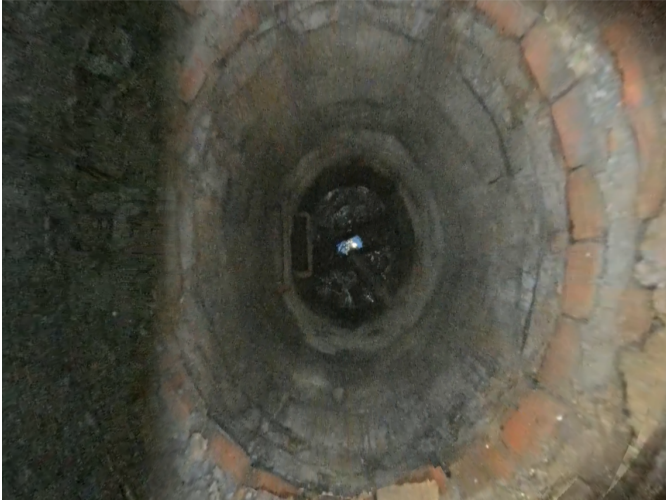
Code: **MGO**
Description: **Miscellaneous General Observation**

Distance: **0ft**
Structural Grade: **0**
O&M Grade: **0**
Clock Start/From:
Clock To:
1st Value:
2nd Value:
Value Percent:
Continuous Index:
Within Eight" of Joint: **False**
Remarks: **Start inspection**

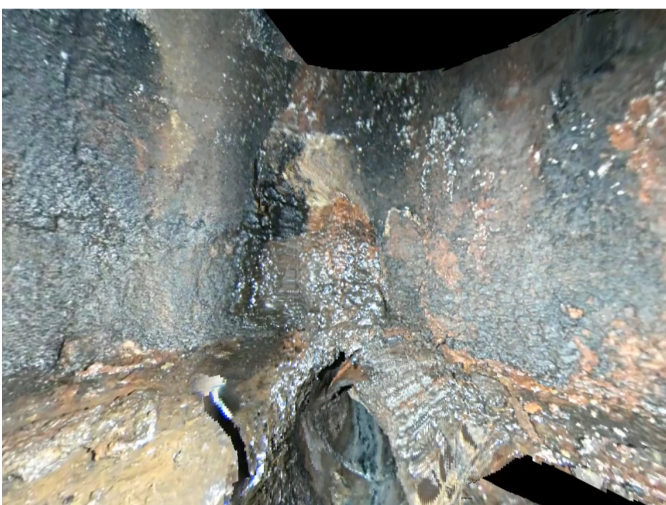
Code: **MGO**
Description: **Miscellaneous General Observation**

Distance: **8ft**
Structural Grade: **0**
O&M Grade: **0**
Clock Start/From:
Clock To:
1st Value:
2nd Value:
Value Percent:
Continuous Index:
Within Eight" of Joint: **False**
Remarks: **End inspection**
