R-030A

S 2ND ST
New Bedford

Inspection Status: Remote Inspection
Inspection Level: Level 2

Project: | New Bedford 3D Regulator Inspections

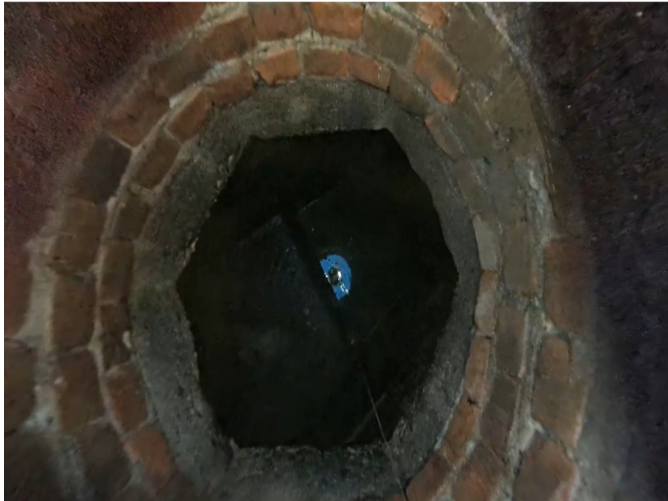
Code: **MGO**
Description: **Miscellaneous General Observation**

Distance: **0ft**
Structural Grade: **0**
O&M Grade: **0**
Clock Start/From:
Clock To:
1st Value:
2nd Value:
Value Percent:
Continuous Index:
Within Eight" of Joint: **False**
Remarks: **Start inspection**

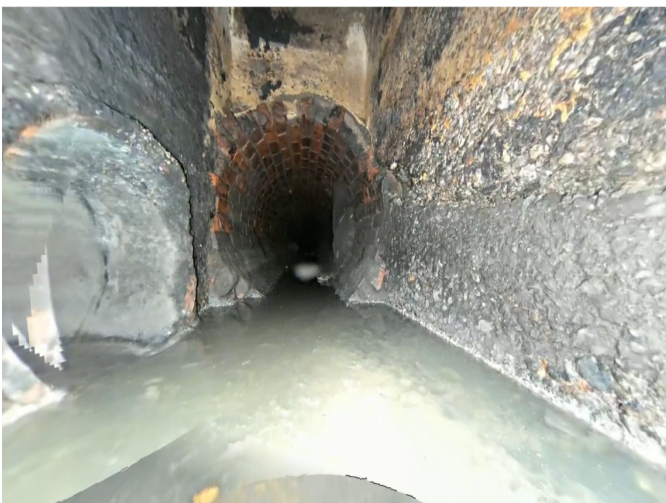
Code: **MGO**
Description: **Miscellaneous General Observation**

Distance: **5ft**
Structural Grade: **0**
O&M Grade: **0**
Clock Start/From:
Clock To:
1st Value:
2nd Value:
Value Percent:
Continuous Index:
Within Eight" of Joint: **False**
Remarks: **End inspection**
