R-031A

S 2ND ST
New Bedford

Project: | New Bedford 3D Regulator Inspections

Condition Report

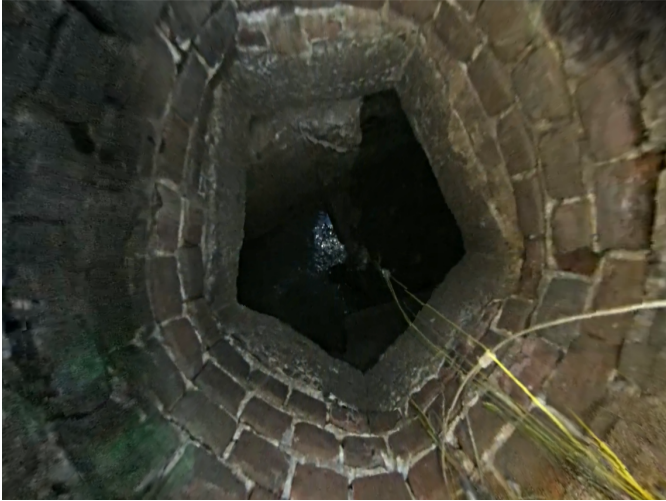
Code: **MGO**
Description: **Miscellaneous General Observation**

Distance: **0ft**
Structural Grade: **0**
O&M Grade: **0**
Clock Start/From:
Clock To:
1st Value:
2nd Value:
Value Percent:
Continuous Index:
Within Eight" of Joint: **False**
Remarks: **Start inspection**

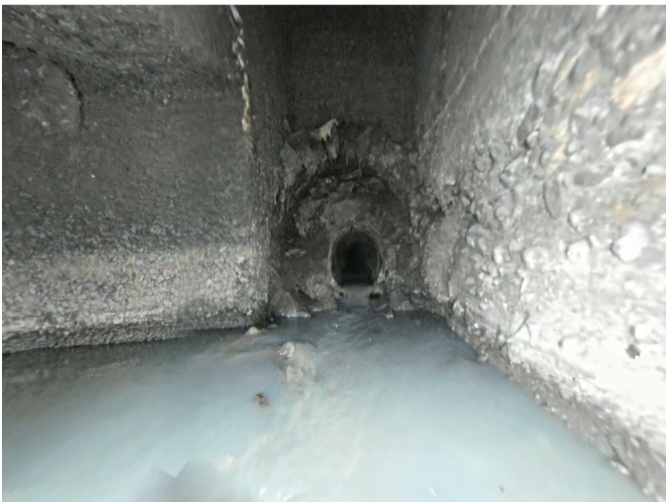
Code: **MGO**
Description: **Miscellaneous General
Observation**

Distance: **5ft**
Structural Grade: **0**
O&M Grade: **0**
Clock Start/From:
Clock To:
1st Value:
2nd Value:
Value Percent:
Continuous Index:
Within Eight" of Joint: **False**
Remarks: **End inspection**
