R-031B

S 2ND ST
New Bedford

Inspection Status: Remote Inspection
Inspection Level: Level 2

Project: | New Bedford 3D Regulator Inspections

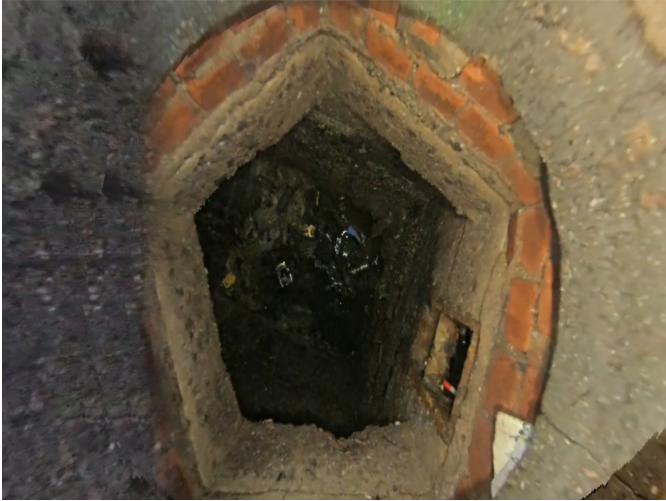
Code: **MGO**
Description: **Miscellaneous General Observation**

Distance: **0ft**
Structural Grade: **0**
O&M Grade: **0**
Clock Start/From:
Clock To:
1st Value:
2nd Value:
Value Percent:
Continuous Index:
Within Eight" of Joint: **False**
Remarks: **Start inspection**

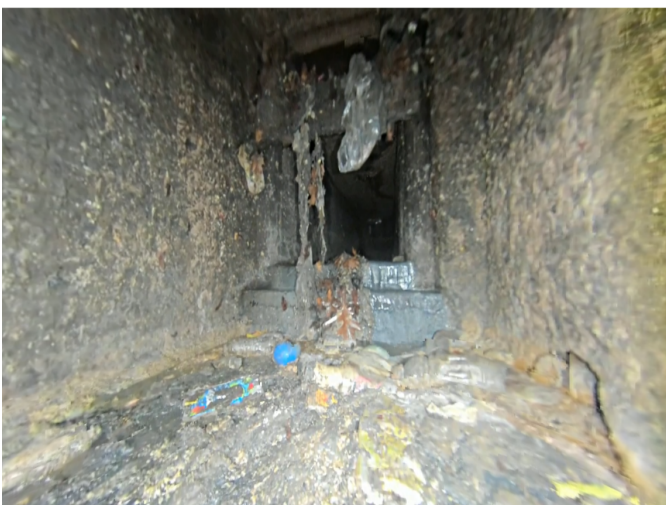
Code: **MGO**
Description: **Miscellaneous General
Observation**

Distance: **5ft**
Structural Grade: **0**
O&M Grade: **0**
Clock Start/From:
Clock To:
1st Value:
2nd Value:
Value Percent:
Continuous Index:
Within Eight" of Joint: **False**
Remarks: **End inspection**
