# R-031C

S 2ND ST  
New Bedford

Inspection Status: Remote Inspection  
Inspection Level: Level 2

**Project:** | New Bedford 3D Regulator Inspections

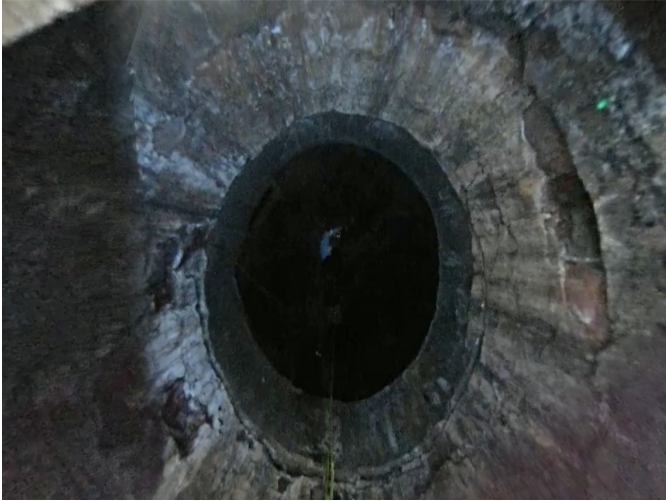
Code: **MGO**  
Description: **Miscellaneous General Observation**

Distance: **0ft**  
Structural Grade: **0**  
O&M Grade: **0**  
Clock Start/From:  
Clock To:  
1st Value:  
2nd Value:  
Value Percent:  
Continuous Index:  
Within Eight" of Joint: **False**  
Remarks: **Start inspection**

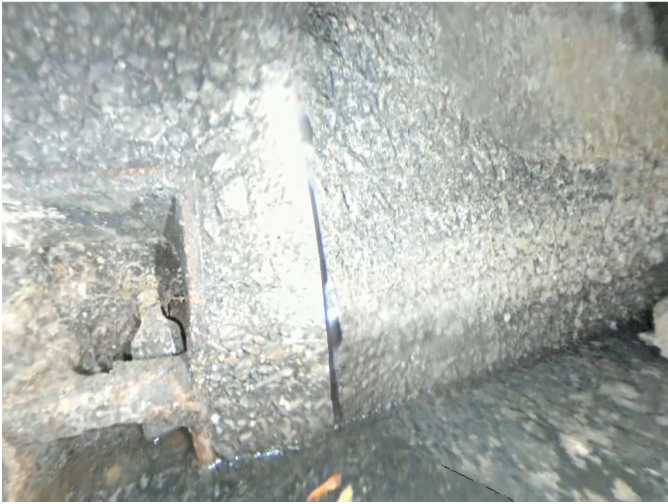
Code: **MGO**  
Description: **Miscellaneous General Observation**

Distance: **6ft**  
Structural Grade: **0**  
O&M Grade: **0**  
Clock Start/From:  
Clock To:  
1st Value:  
2nd Value:  
Value Percent:  
Continuous Index:  
Within Eight" of Joint: **False**  
Remarks: **End inspection**
