R-031E

JFK MEMORIAL HWY
New Bedford

Inspection Status: Remote Inspection
Inspection Level: Level 2

Project: | New Bedford 3D Regulator Inspections

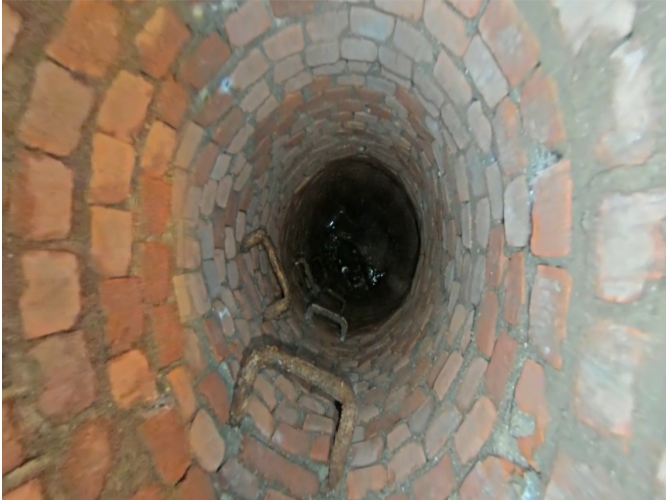
Code: **MGO**
Description: **Miscellaneous General Observation**

Distance: **0ft**
Structural Grade: **0**
O&M Grade: **0**
Clock Start/From:
Clock To:
1st Value:
2nd Value:
Value Percent:
Continuous Index:
Within Eight" of Joint: **False**
Remarks: **Start inspection**

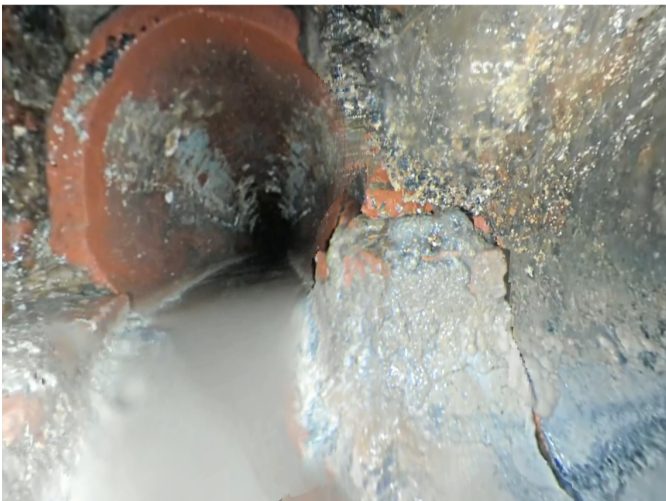
Code: **MGO**
Description: **Miscellaneous General Observation**

Distance: **12ft**
Structural Grade: **0**
O&M Grade: **0**
Clock Start/From:
Clock To:
1st Value:
2nd Value:
Value Percent:
Continuous Index:
Within Eight" of Joint: **False**
Remarks: **End inspection**
