R-032B

S 2ND ST
New Bedford

Inspection Status: Remote Inspection
Inspection Level: Level 2

Project: | New Bedford 3D Regulator Inspections

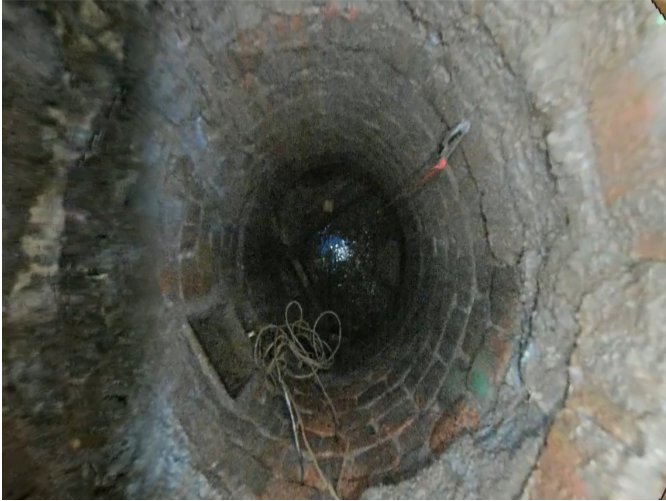
Code: **MGO**
Description: **Miscellaneous General Observation**

Distance: **0ft**
Structural Grade: **0**
O&M Grade: **0**
Clock Start/From:
Clock To:
1st Value:
2nd Value:
Value Percent:
Continuous Index:
Within Eight" of Joint: **False**
Remarks: **Start inspection**

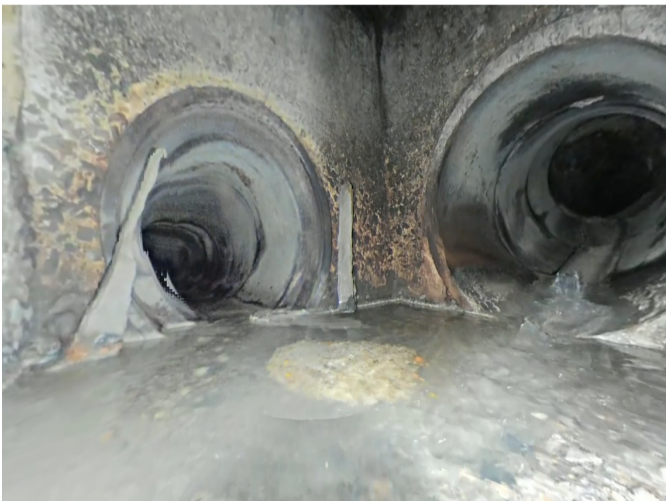
Code: **MGO**
Description: **Miscellaneous General
Observation**

Distance: **7ft**
Structural Grade: **0**
O&M Grade: **0**
Clock Start/From:
Clock To:
1st Value:
2nd Value:
Value Percent:
Continuous Index:
Within Eight" of Joint: **False**
Remarks: **End inspection**
