R-032D

GRIFFIN ST
New Bedford

Inspection Status: Remote Inspection
Inspection Level: Level 2

Project: | New Bedford 3D Regulator Inspections

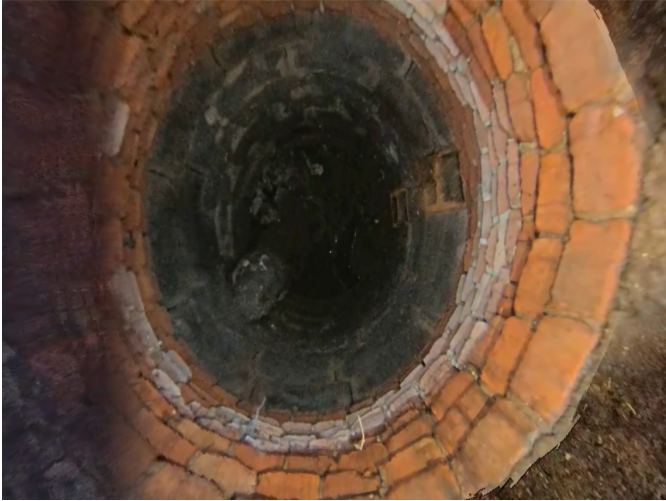
Code: **MGO**
Description: **Miscellaneous General Observation**

Distance: **0ft**
Structural Grade: **0**
O&M Grade: **0**
Clock Start/From:
Clock To:
1st Value:
2nd Value:
Value Percent:
Continuous Index:
Within Eight" of Joint: **False**
Remarks: **Start inspection**

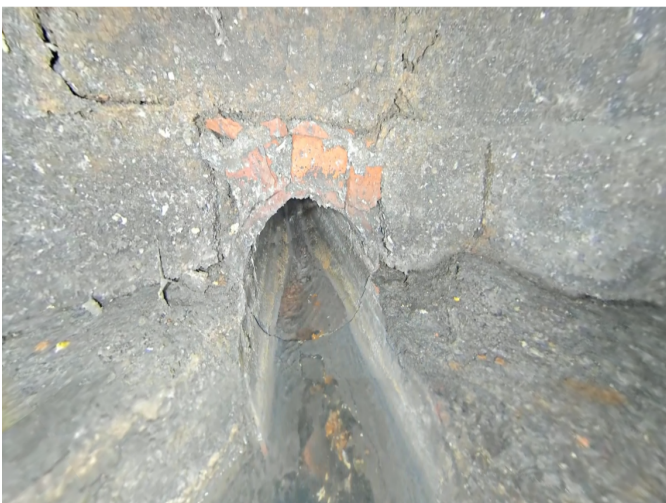
Code: **MGO**
Description: **Miscellaneous General Observation**

Distance: **7ft**
Structural Grade: **0**
O&M Grade: **0**
Clock Start/From:
Clock To:
1st Value:
2nd Value:
Value Percent:
Continuous Index:
Within Eight" of Joint: **False**
Remarks: **End inspection**
