# R-035A

HILLMAN ST  
New Bedford

**Project:** | New Bedford 3D Regulator Inspections

# Condition Report

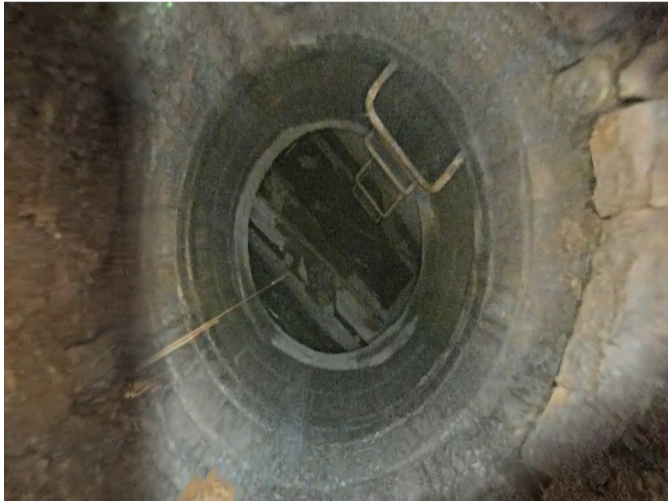
Code: **MGO**  
Description: **Miscellaneous General Observation**

Distance: **0ft**  
Structural Grade: **0**  
O&M Grade: **0**  
Clock Start/From:  
Clock To:  
1st Value:  
2nd Value:  
Value Percent:  
Continuous Index:  
Within Eight" of Joint: **False**  
Remarks: **Start inspection**

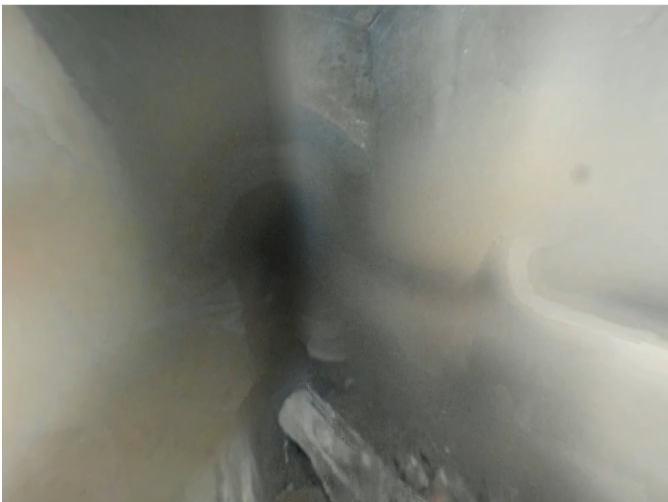
Code: **MGO**  
Description: **Miscellaneous General Observation**

Distance: **6ft**  
Structural Grade: **0**  
O&M Grade: **0**  
Clock Start/From:  
Clock To:  
1st Value:  
2nd Value:  
Value Percent:  
Continuous Index:  
Within Eight" of Joint: **False**  
Remarks: **End inspection**
