R-035B

MAXFIELD ST
New Bedford

Inspection Status: Remote Inspection
Inspection Level: Level 2

Project: | New Bedford 3D Regulator Inspections

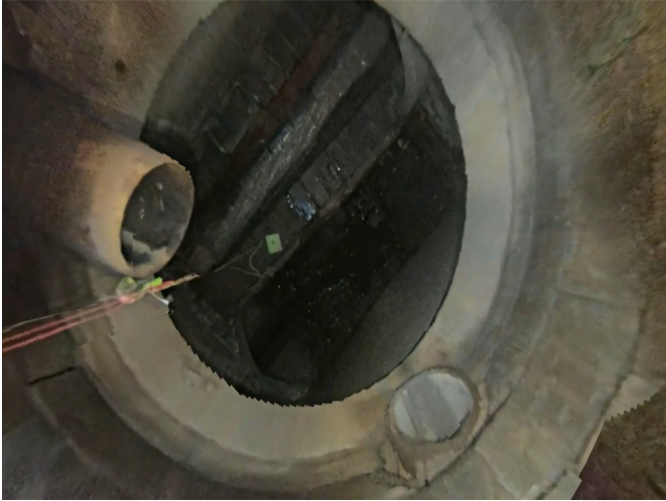
Code: **MGO**
Description: **Miscellaneous General Observation**

Distance: **0ft**
Structural Grade: **0**
O&M Grade: **0**
Clock Start/From:
Clock To:
1st Value:
2nd Value:
Value Percent:
Continuous Index:
Within Eight" of Joint: **False**
Remarks: **Start inspection**

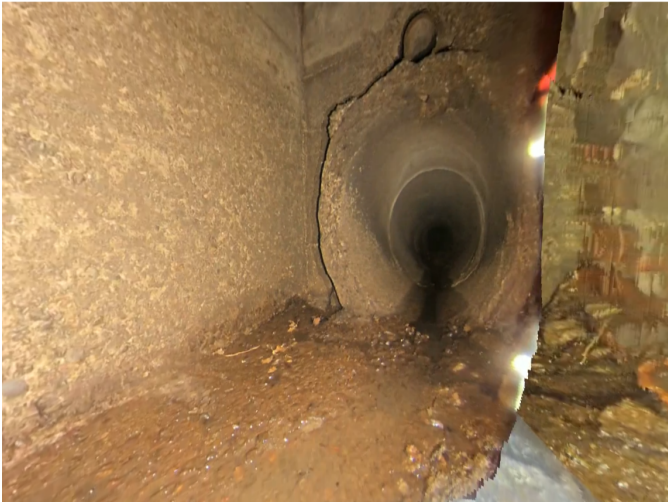
Code: **MGO**
Description: **Miscellaneous General Observation**

Distance: **6ft**
Structural Grade: **0**
O&M Grade: **0**
Clock Start/From:
Clock To:
1st Value:
2nd Value:
Value Percent:
Continuous Index:
Within Eight" of Joint: **False**
Remarks: **End inspection**
