R-035C

A CUSHNET AVE
New Bedford

Project: | New Bedford 3D Regulator Inspections

Condition Report

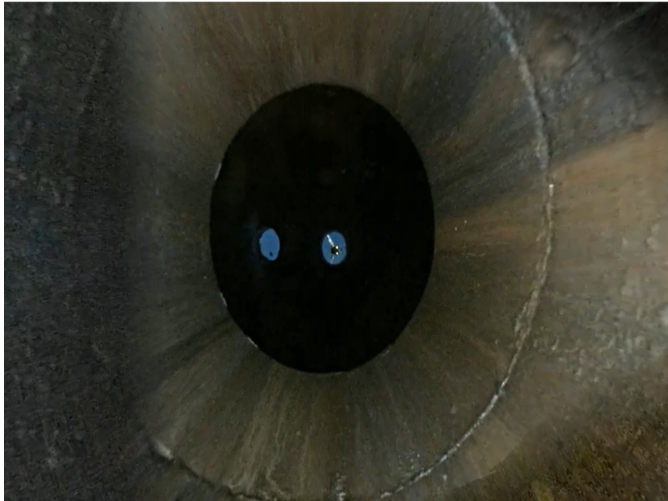
Code: **MGO**
Description: **Miscellaneous General Observation**

Distance: **0ft**
Structural Grade: **0**
O&M Grade: **0**
Clock Start/From:
Clock To:
1st Value:
2nd Value:
Value Percent:
Continuous Index:
Within Eight" of Joint: **False**
Remarks: **Start inspection**

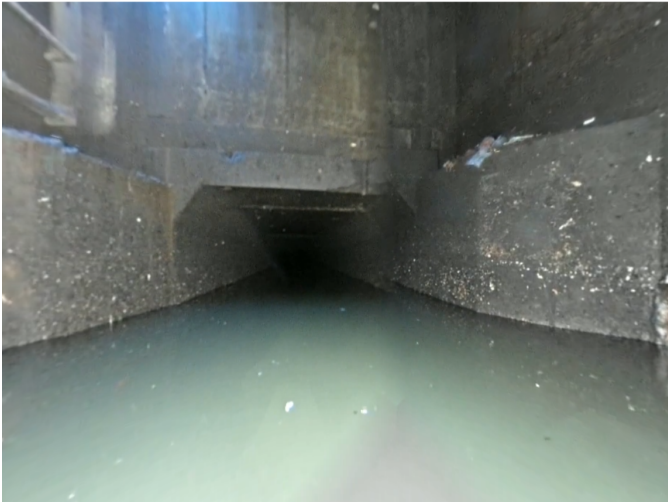
Code: **MGO**
Description: **Miscellaneous General Observation**

Distance: **10ft**
Structural Grade: **0**
O&M Grade: **0**
Clock Start/From:
Clock To:
1st Value:
2nd Value:
Value Percent:
Continuous Index:
Within Eight" of Joint: **False**
Remarks: **End inspection**
