R-037A

PURCHASE ST
New Bedford

Inspection Status: Remote Inspection
Inspection Level: Level 2

Project: | New Bedford 3D Regulator Inspections

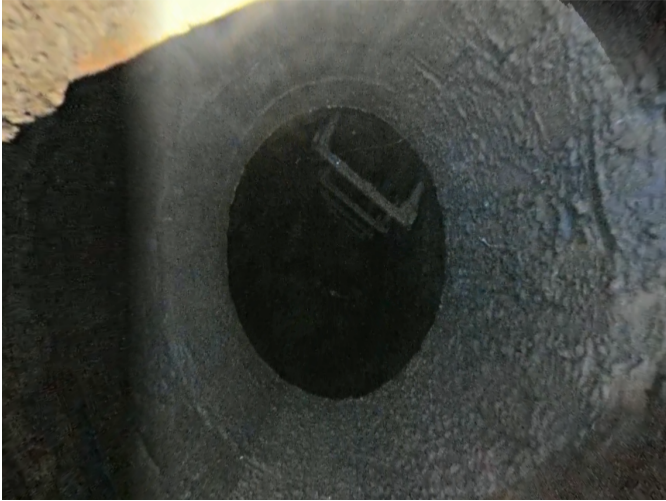
Code: **MGO**
Description: **Miscellaneous General Observation**

Distance: **0ft**
Structural Grade: **0**
O&M Grade: **0**
Clock Start/From:
Clock To:
1st Value:
2nd Value:
Value Percent:
Continuous Index:
Within Eight" of Joint: **False**
Remarks: **Start inspection**

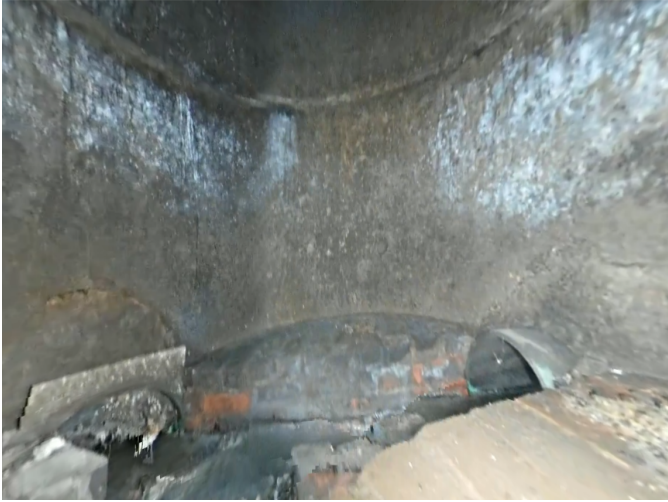
Code: **MGO**
Description: **Miscellaneous General Observation**

Distance: **9ft**
Structural Grade: **0**
O&M Grade: **0**
Clock Start/From:
Clock To:
1st Value:
2nd Value:
Value Percent:
Continuous Index:
Within Eight" of Joint: **False**
Remarks: **End inspection**
