R-037

WALNUT ST
New Bedford

Inspection Status: Remote Inspection
Inspection Level: Level 2

Project: | New Bedford 3D Regulator Inspections

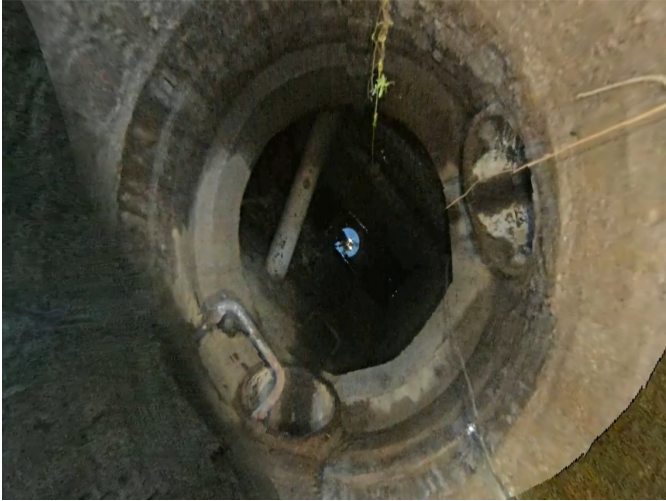
Code: **MGO**
Description: **Miscellaneous General Observation**

Distance: **0ft**
Structural Grade: **0**
O&M Grade: **0**
Clock Start/From:
Clock To:
1st Value:
2nd Value:
Value Percent:
Continuous Index:
Within Eight" of Joint: **False**
Remarks: **Start inspection**

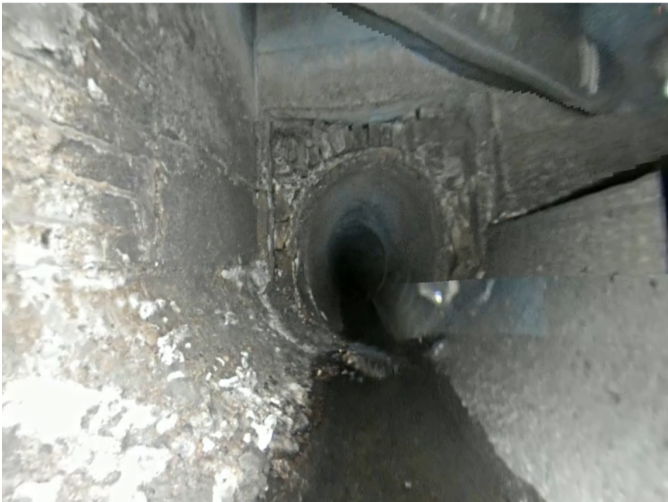
Code: **MGO**
Description: **Miscellaneous General Observation**

Distance: **7ft**
Structural Grade: **0**
O&M Grade: **0**
Clock Start/From:
Clock To:
1st Value:
2nd Value:
Value Percent:
Continuous Index:
Within Eight" of Joint: **False**
Remarks: **End inspection**
