# R-040A

GOGGESHALL ST  
New Bedford

**Project:** | New Bedford 3D Regulator Inspections

# Condition Report

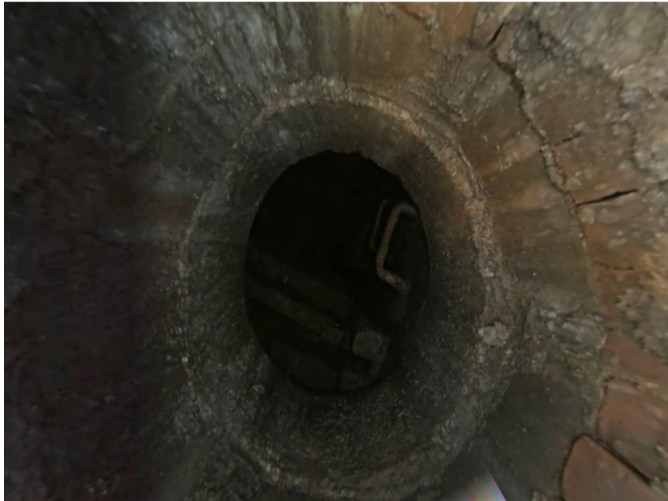
Code: **MGO**  
Description: **Miscellaneous General Observation**

Distance: **0ft**  
Structural Grade: **0**  
O&M Grade: **0**  
Clock Start/From:  
Clock To:  
1st Value:  
2nd Value:  
Value Percent:  
Continuous Index:  
Within Eight" of Joint: **False**  
Remarks: **Start inspection**

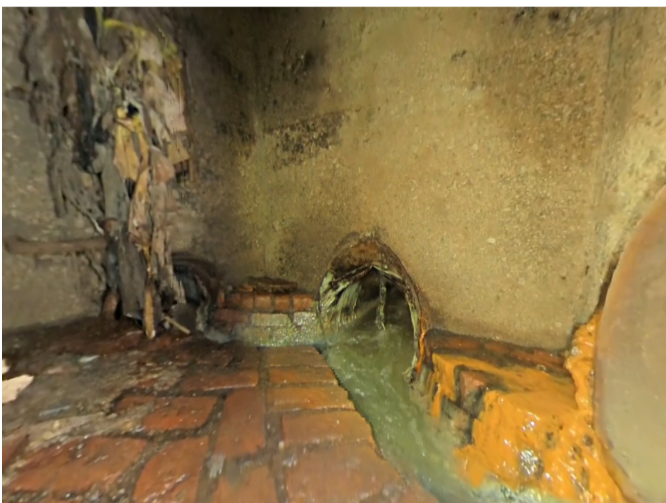
Code: **MGO**  
Description: **Miscellaneous General  
Observation**

Distance: **14ft**  
Structural Grade: **0**  
O&M Grade: **0**  
Clock Start/From:  
Clock To:  
1st Value:  
2nd Value:  
Value Percent:  
Continuous Index:  
Within Eight" of Joint: **False**  
Remarks: **End inspection**
