# R-041B

BELLEVILLE AVE  
New Bedford

Inspection Status: Remote Inspection  
Inspection Level: Level 2

**Project:** | New Bedford 3D Regulator Inspections

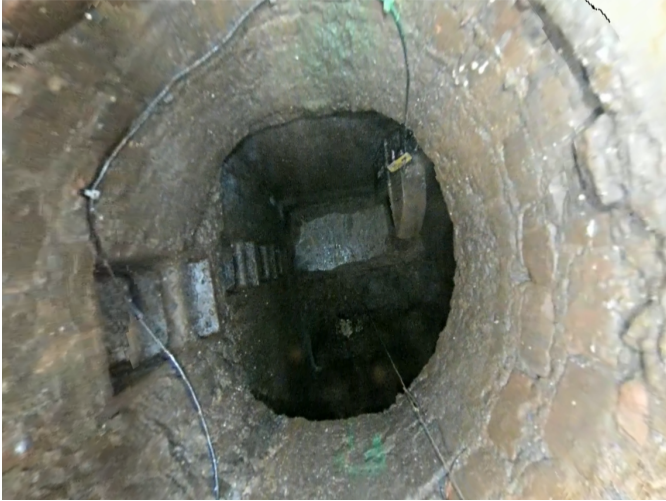
Code: **MGO**  
Description: **Miscellaneous General Observation**

Distance: **0ft**  
Structural Grade: **0**  
O&M Grade: **0**  
Clock Start/From:  
Clock To:  
1st Value:  
2nd Value:  
Value Percent:  
Continuous Index:  
Within Eight" of Joint: **False**  
Remarks: **Start inspection**

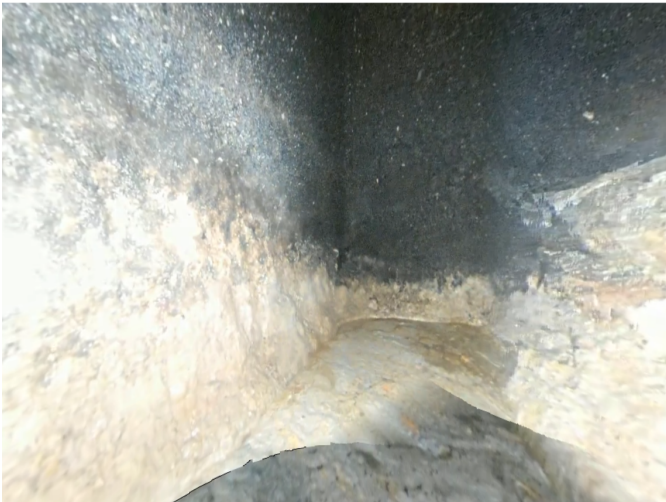
Code: **MGO**  
Description: **Miscellaneous General Observation**

Distance: **7ft**  
Structural Grade: **0**  
O&M Grade: **0**  
Clock Start/From:  
Clock To:  
1st Value:  
2nd Value:  
Value Percent:  
Continuous Index:  
Within Eight" of Joint: **False**  
Remarks: **End inspection**
