CSO SPEC SHEET

CSO FIELD PHOTOS

Structure#: Regulator 004B

Location: Orchard St. and Cove Rd.

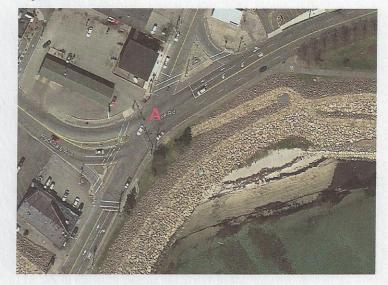
Figure 4.

- **Figure 1:** Street view of open manhole to regulator 004B showing sewer incoming and outgoing directions as well as the storm drain outfall.
- Figure 2: Inside view of manhole. A- Sewer; B- Weir Wall; C- Storm Drain; D- Break in weir wall.
- Figure 3: Street view of Regulator 004B, Facing the Northwest towards carwash.
- Figure 4: Google Earth image of intersection where Regulator 004B is located. A- Regulator 004B
