R-004D

RIVET ST
New Bedford

Inspection Status: Remote Inspection
Inspection Level: Level 2

Project: | New Bedford 3D Regulator Inspections
Owner: New Bedford, MA
Customer: CDM Smith

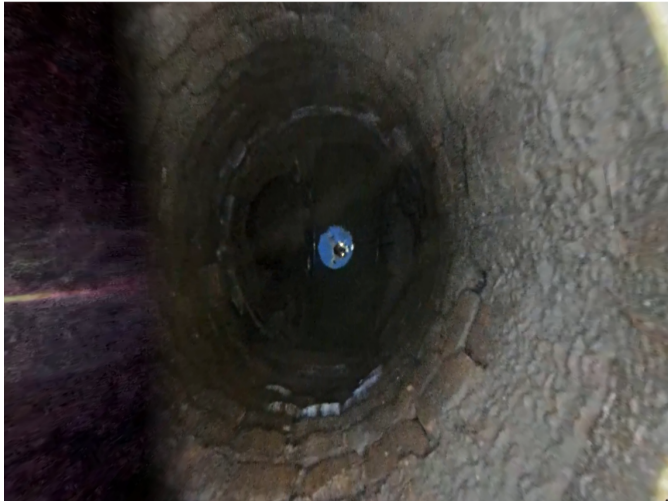
Code: **MGO**
Description: **Miscellaneous General Observation**

Distance: **0ft**
Structural Grade: **0**
O&M Grade: **0**
Clock Start/From:
Clock To:
1st Value:
2nd Value:
Value Percent:
Continuous Index:
Within Eight" of Joint: **False**
Remarks: **Start inspection**

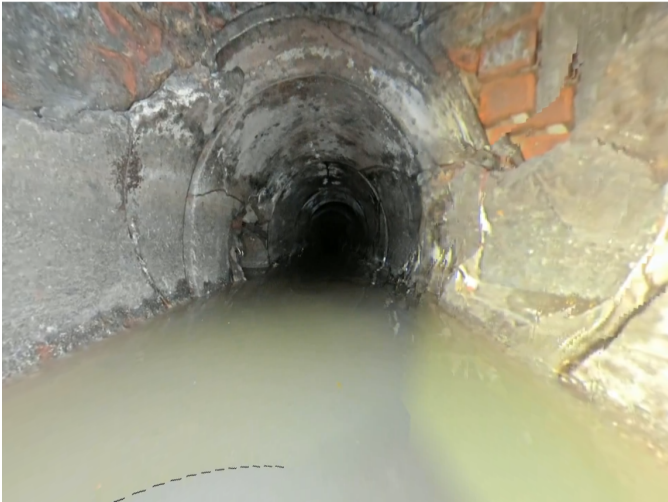
Code: **MGO**
Description: **Miscellaneous General Observation**

Distance: **6ft**
Structural Grade: **0**
O&M Grade: **0**
Clock Start/From:
Clock To:
1st Value:
2nd Value:
Value Percent:
Continuous Index:
Within Eight" of Joint: **False**
Remarks: **End inspection**
