# **CSO SPEC SHEET**

Structure #: REG 005 A

**Date:** 08/20/2012 **Insp. By:** AH and AK

#### Location: At the Intersection of Dudley St and French Rodney Blvd.

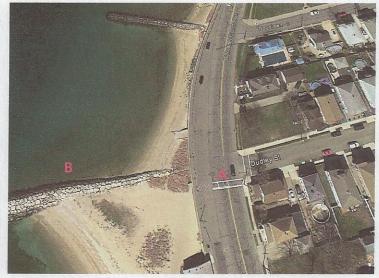
Figure 4.

- Figure 1: Street view of Regulator 005 A. Facing East.
- Figure 2: Inside view of manhole. A-Storm Drain; B- Weir Wall; C- Sewer.
- Figure 3: Street view of Regulator 005 A. Facing Clark's Cove.
- Figure 4: Google Earth image of Regulator 005 A. A- REG 005A; B- CSO 005 outfall pipe.
