# R-005A

DUDLEY ST  
New Bedford

Inspection Status: Remote Inspection  
Inspection Level: Level 2

Project: | New Bedford 3D Regulator Inspections

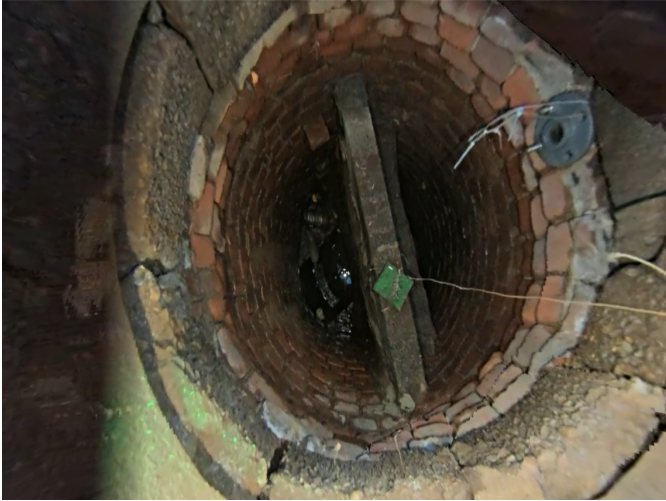
Code: **MGO**  
Description: **Miscellaneous General Observation**

Distance: **0ft**  
Structural Grade: **0**  
O&M Grade: **0**  
Clock Start/From:  
Clock To:  
1st Value:  
2nd Value:  
Value Percent:  
Continuous Index:  
Within Eight" of Joint: **False**  
Remarks: **Start inspection**

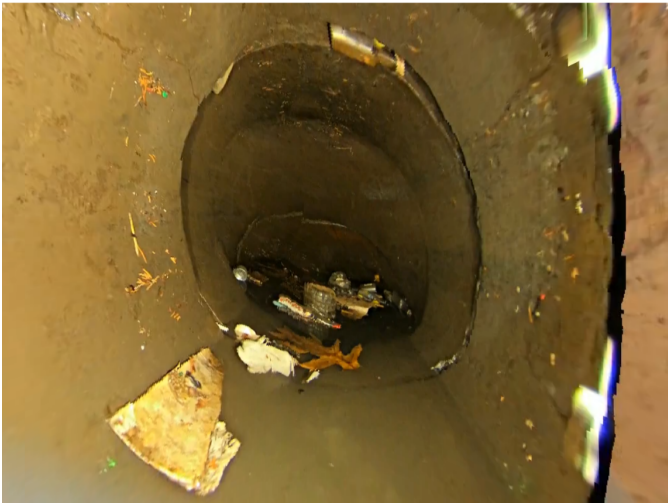
Code: **MGO**  
Description: **Miscellaneous General Observation**

Distance: **6ft**  
Structural Grade: **0**  
O&M Grade: **0**  
Clock Start/From:  
Clock To:  
1st Value:  
2nd Value:  
Value Percent:  
Continuous Index:  
Within Eight" of Joint: **False**  
Remarks: **End inspection**
