R-012B

BELLEVUE ST
New Bedford

Inspection Status: Remote Inspection
Inspection Level: Level 2

Project: | New Bedford 3D Regulator Inspections

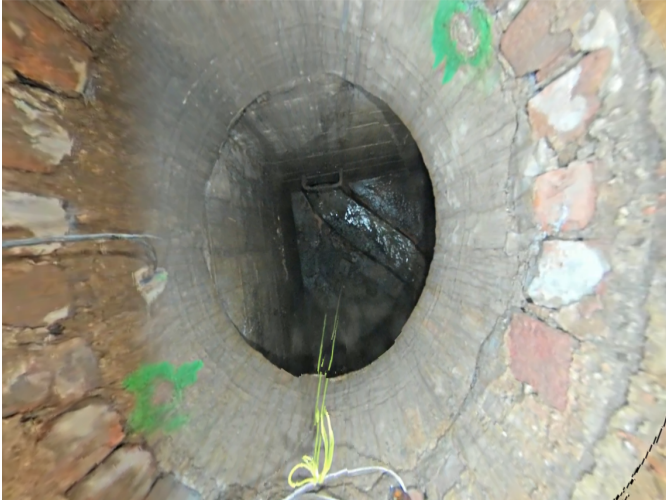
Code: **MGO**
Description: **Miscellaneous General Observation**

Distance: **0ft**
Structural Grade: **0**
O&M Grade: **0**
Clock Start/From:
Clock To:
1st Value:
2nd Value:
Value Percent:
Continuous Index:
Within Eight" of Joint: **False**
Remarks: **Start inspection**

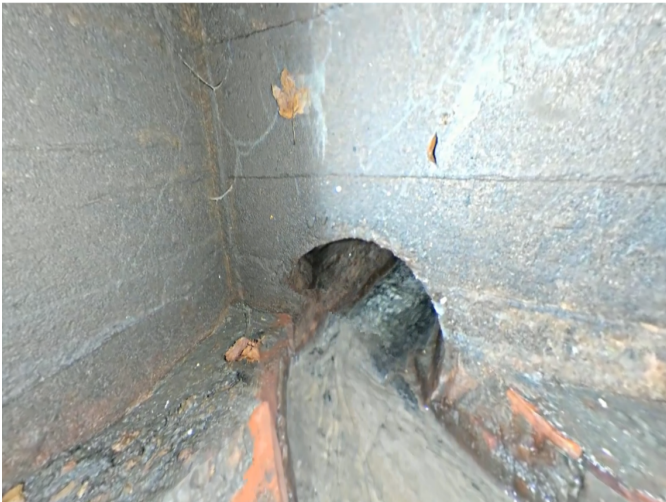
Code: **MGO**
Description: **Miscellaneous General Observation**

Distance: **5ft**
Structural Grade: **0**
O&M Grade: **0**
Clock Start/From:
Clock To:
1st Value:
2nd Value:
Value Percent:
Continuous Index:
Within Eight" of Joint: **False**
Remarks: **End inspection**
